Appendix G: 2310 Horse Stamp Church Road Basin Photo Sheets 1-10

Appendix H: Historical Aerials, dating 1988-2022

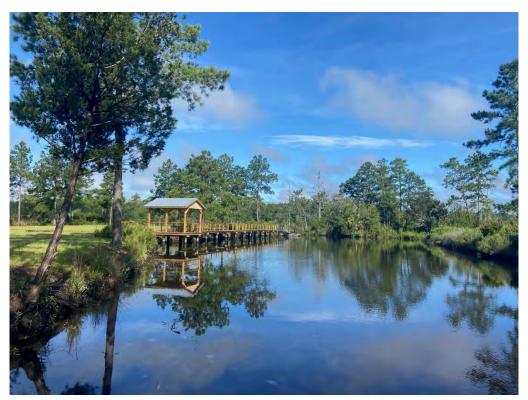
Photo 1: Facing west at dock from east side of basin

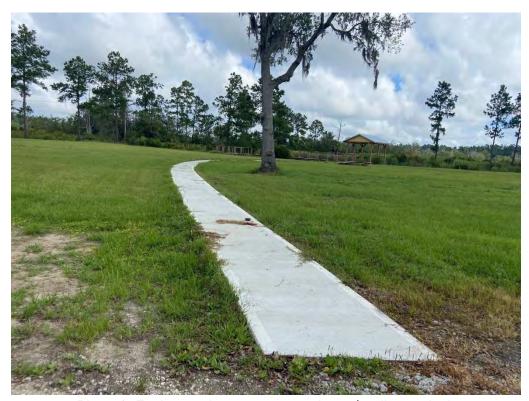
Photo 2: Facing north at concrete pathway leading to dock

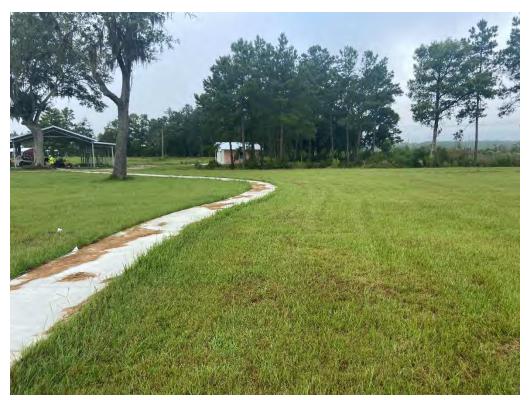
Photo 3: Facing south at concrete pathway away from dock

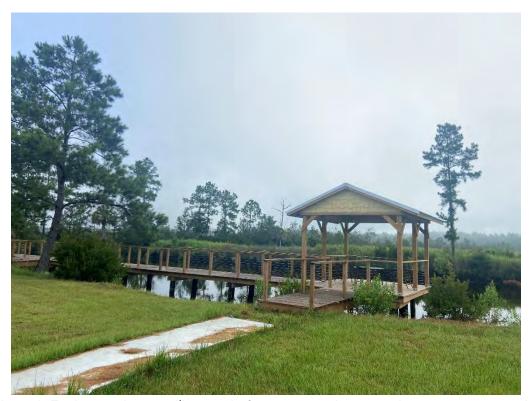
Photo 4: Facing north at pavilion, end of concrete pathway, and eastern access point

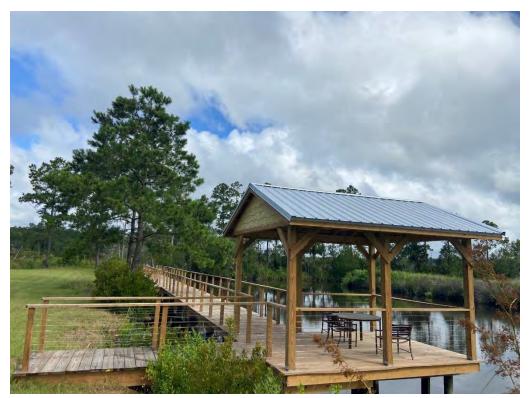
Photo 5: Facing west at pavilion and eastern access point

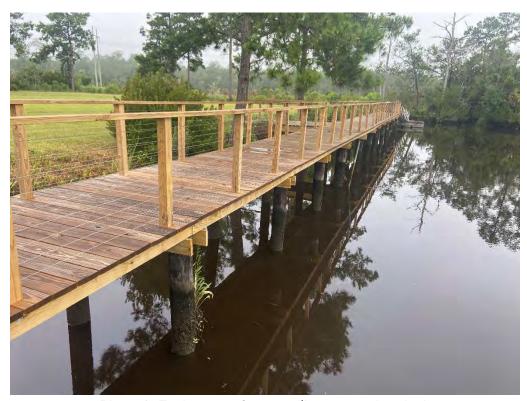
Photo 6: Facing west from pavilion at wooden dock

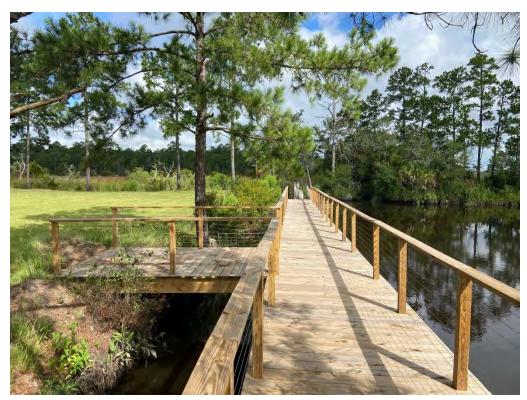
Photo 7: Facing west at wooden dock and western access point

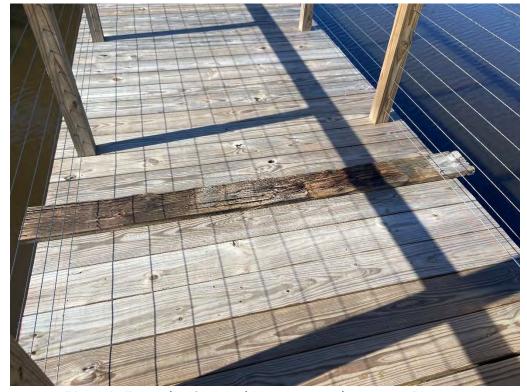
Photo 8: Example of original boards vs replacement 7' boards

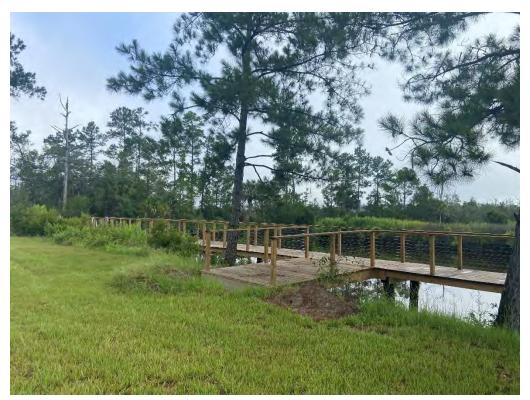
Photo 9: Facing north at western access point

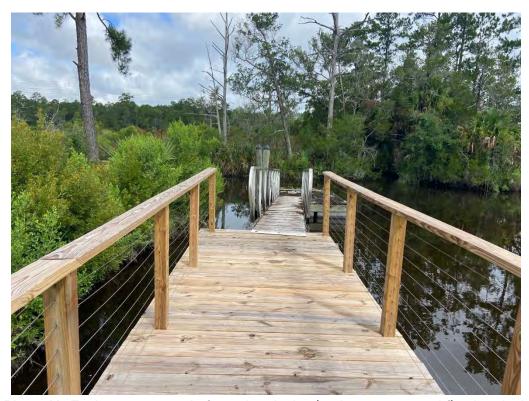
Photo 10: Facing west at end of wooden dock, aluminum ramp, and floating dock

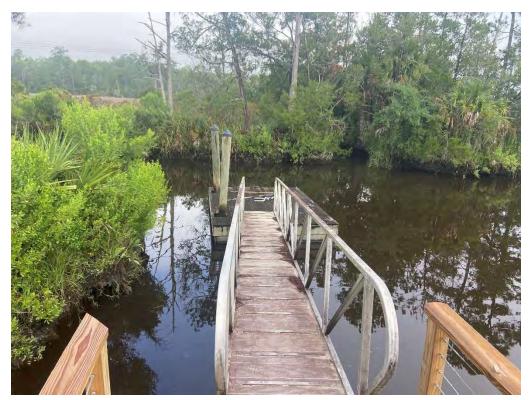
Photo 11: Facing west down aluminum ramp at floating dock

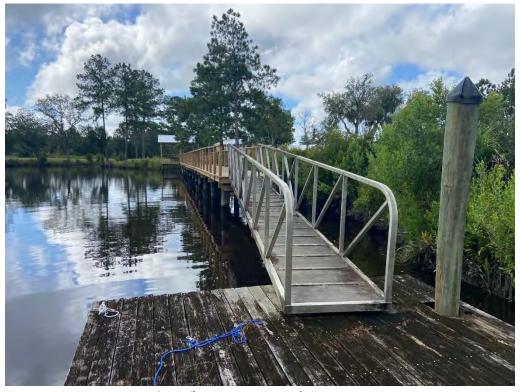
Photo 12: Facing east from floating dock at aluminum ramp and wooden dock

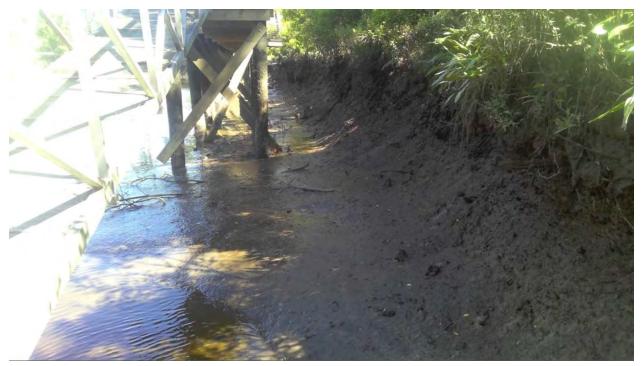
Photo 13: Facing east from floating dock at underside of wooden dock

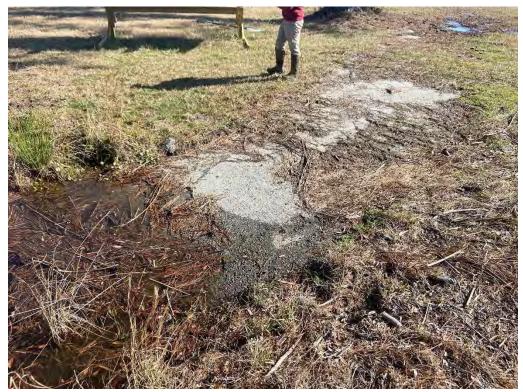
Photo 14: Facing east at asphalt boat ramp located in the southeast corner of the basin

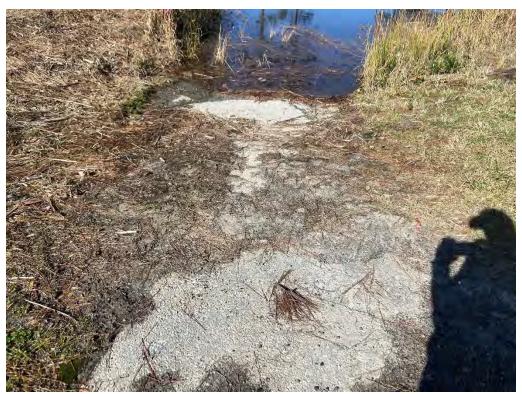
Photo 15: Facing north at asphalt boat ramp located in the southeast corner of the basin

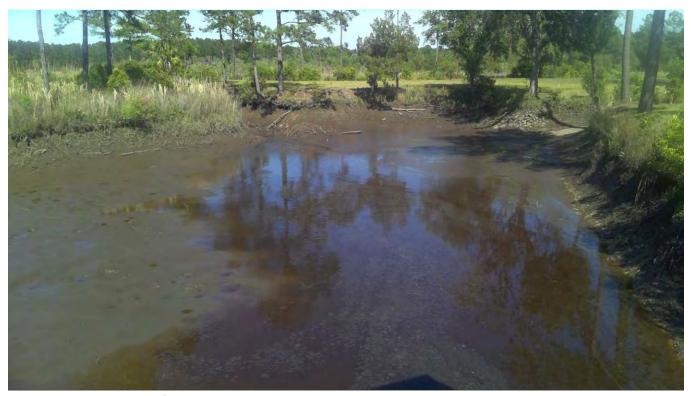
Photo 16: Facing east from pavilion at basin during low tide, the asphalt boat ramp termination point can be sees in the upper right-hand corner of the photo

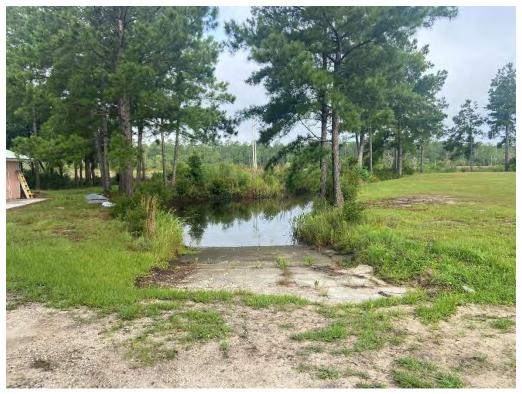
Photo 17: Facing west at concrete boat ramp located southwest of the basin

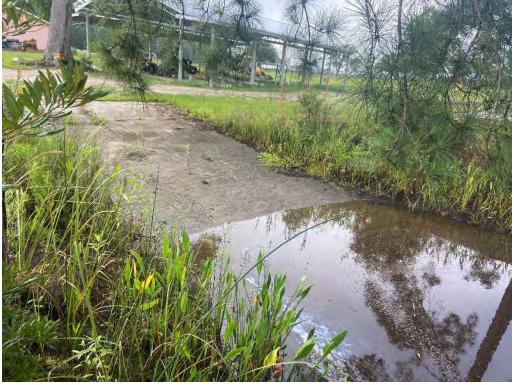
Photo 18: Facing south at concrete boat ramp located southwest of the basin

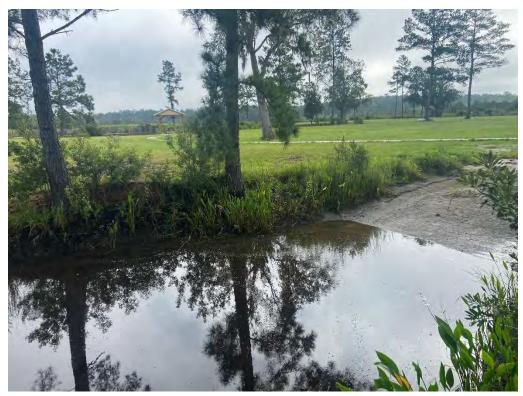
Photo 19: Facing north at concrete boat ramp. The wooden dock and concrete walkway can be seen in the background.

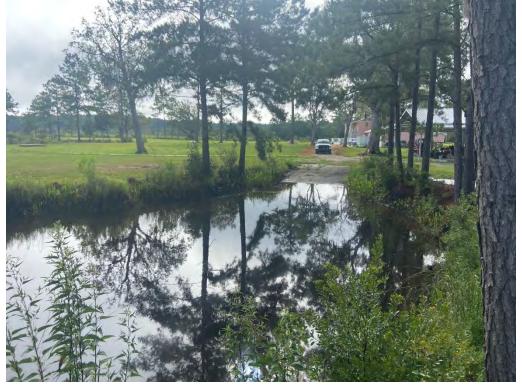
Photo 20: Facing east at the channel and concrete boat ramp
