# Infiltration Study

*A pilot study to compliment the 2021-2022 LID Inventory  
Summary Document*

*Georgia Department of Natural Resources, Coastal Resources Division*

*University of Georgia Marine Extension and Georgia Sea Grant*

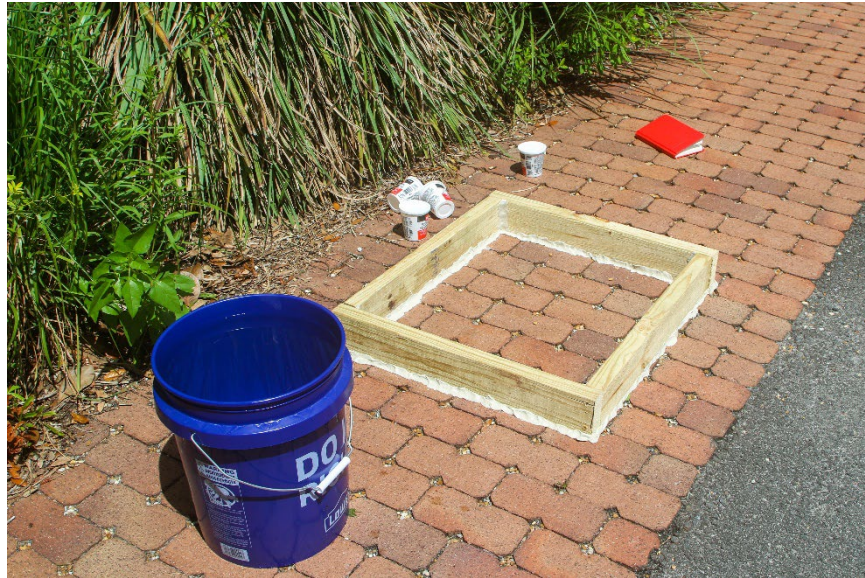
Figure 2. Simple Infiltration Test

The SIT infiltrometer was constructed with materials purchased from a local hardware store, secured in place with plumber's putty applied on both inner and outer edges of where the infiltrometer met the permeable pavement surface, and five gallons of water was poured into the infiltrometer to start the test. Three test locations were randomly identified at each site, before arriving on site, and they represented an even distribution

of surface area. A minimum of three SIT replicates were conducted at each of the 12 sites, and the time to infiltrate five gallons was recorded (36 total SITs). Each test was stopped after five minutes and relative water level within the infiltrrometer was noted.

Property owners and managers for each site were contacted, and following their permission, each site was evaluated using the Simple Infiltration Test (SIT), developed by North Carolina State University (Winston, et. al., 2016). The SIT methodology was selected because of its replicability, cost of equipment and materials, and test time in comparison with the ASTM test standard. In addition to determining infiltration rates of permeable pavement in coastal Georgia, selecting a methodology that can be taught to local stormwater managers and one that can provide consistent results throughout the region became an important objective.

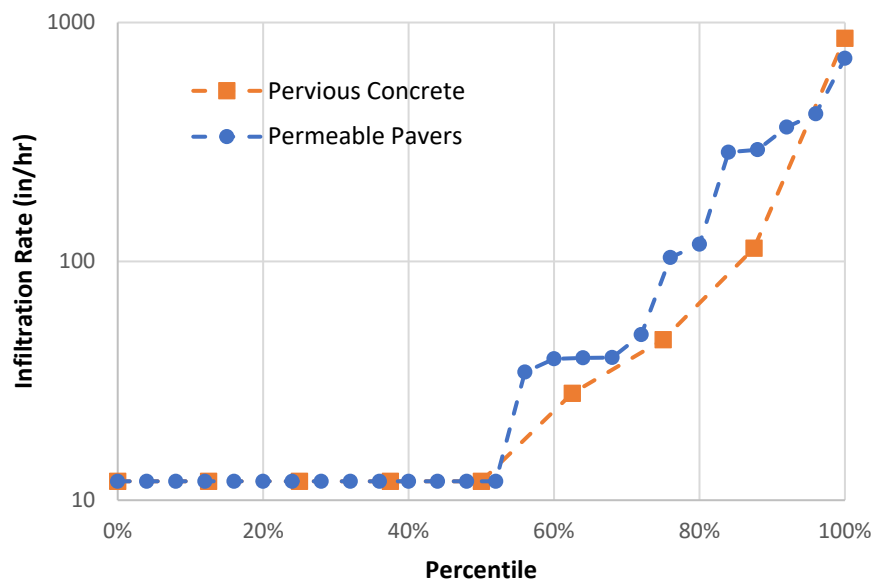
Figure 4. Infiltration Rate by Pavement Type

Of the twelve sites assessed, the pavement type was predominately permeable pavers (PICP, n=9), with only three sites having pervious concrete applications. This breakdown, 75% permeable pavers and 25% pervious concrete, is representative of the overall dataset permeable pavement breakdown for the 2022 Inventory and similar to the 2017 Inventory (66% permeable pavers, 28% pervious concrete, 6% other). For each test, the volume (five gallons or 0.67 CUFT) per test time was converted to infiltration rate (in/hr), based on the surface area (4 SQFT). For the average of three tests per site, both pavement types experienced a range of infiltration rates that were as high as 340 in/hr for pervious concrete and 413.5 in/hr for PICP. When clogged, both pavement types also had infiltration rates as low as the minimum testing value (>5 minutes). The distribution of infiltration rates based on permeable pavement type, as shown in Figure 4, were consistent for the collective dataset.

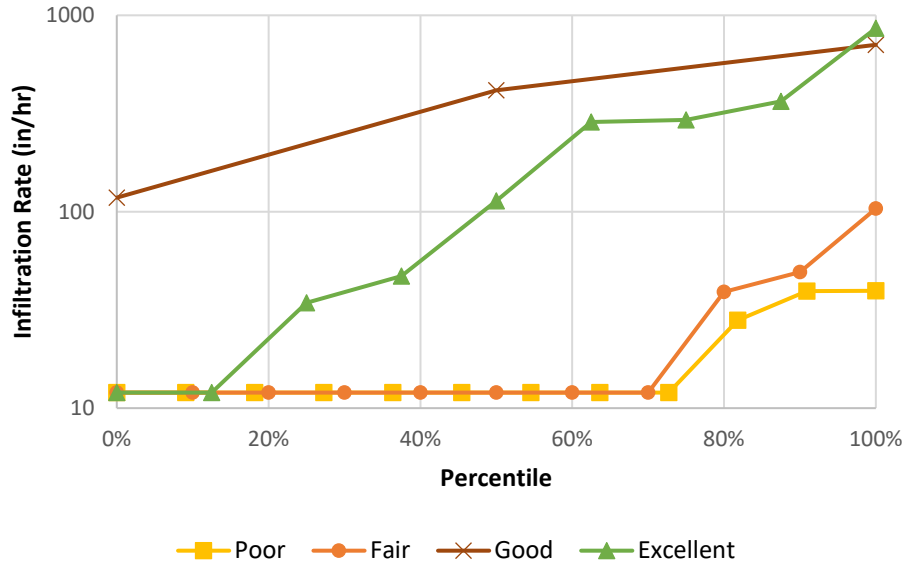
Figure 5. Perceived Effectiveness Rating and Infiltration Rate

Additionally, when comparing the perceived effectiveness with infiltration rate the response from recent assessments (2021-2022) is clearly demonstrated, as shown in Figure 5. Ratings of “excellent” or “good” correspond with high infiltration rates (three out of four sites had an average site infiltration rate of greater than 300 in/hr) and “fair”

and “poor” are consistently very low. Unfortunately, five out of the eight sites had all SIT tests time out (>5 minutes) or infiltration rates less than 24 in/hr, and this included two “poor” and three “fair” sites. One “excellent” site had an average infiltration rate of 19.5 in/hr, which indicates that there may be an underlying issue that was not identified with the visual inspection.
