Living Shorelines along the Georgia Coast

A summary report of the first Living Shoreline projects in Georgia

Living Shoreline Summary Report

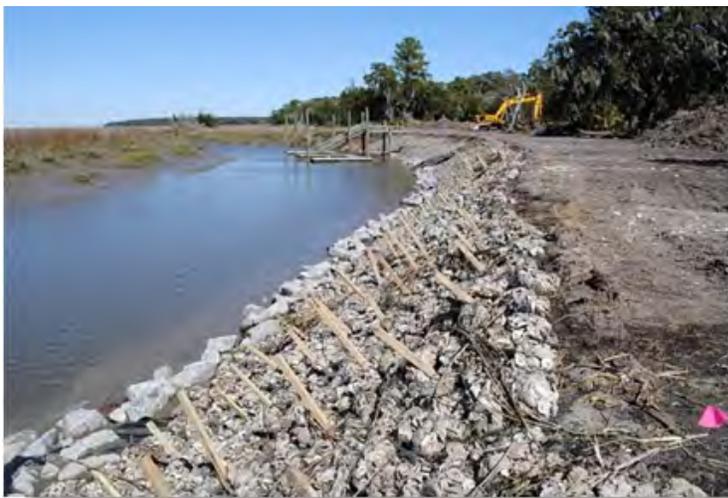
Ashantilly site construction photo

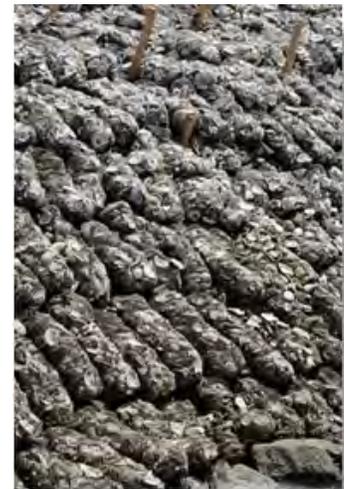
Detail of Ashantilly site oyster bag placement

Geotextile fabric (an extremely durable woven plastic fabric) was installed on the lower embankment and a five foot wide area of surge stone was placed on the geotextile. Surge stone, also known as #1 rip rap, consists of large granite stone weighing approximately 125 pounds each and measuring 24” in diameter. The design included plantings at the top of the embankment of low and high marsh vegetation, as well as appropriate native upland grasses and shrubs.

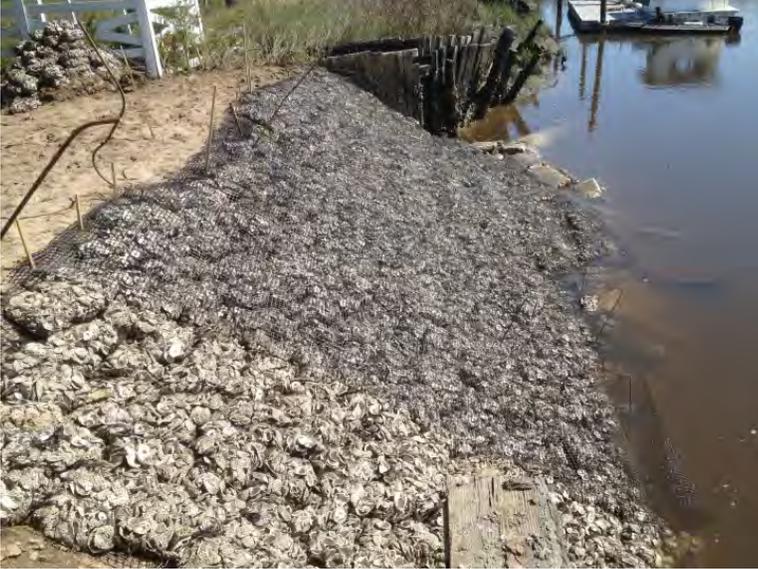
*Bottom course of oyster bags wrapped in geogrid.
Little St. Simons Island, GA*

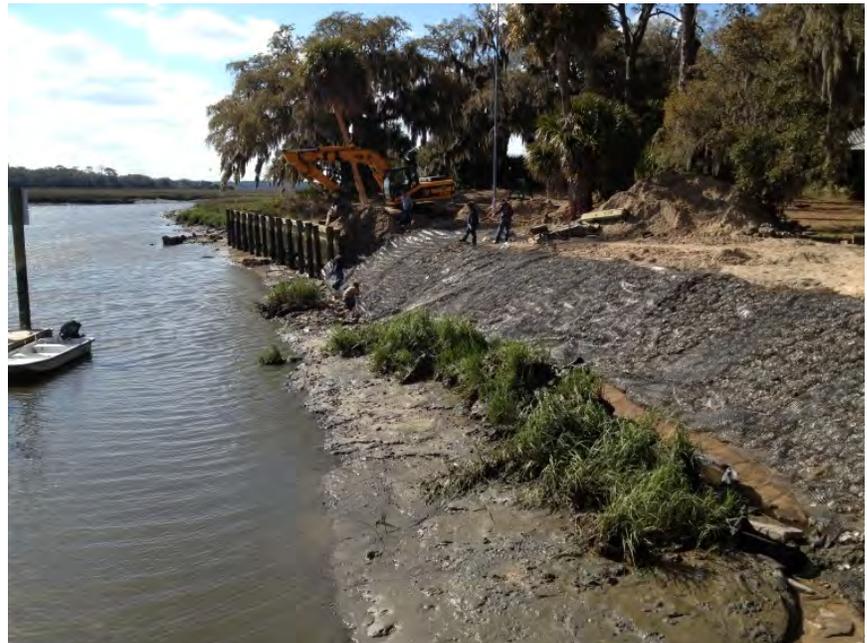
*Bottom course of oyster bags wrapped in geogrid
after bulkhead removal.
Little St. Simons Island, GA.*

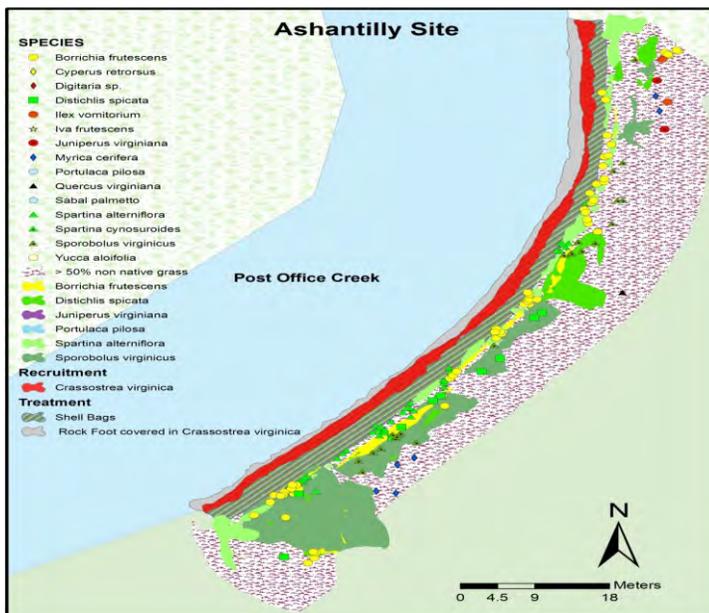
Figure 5: GPS qualitative mapping of the Ashantilly site showing supra-tidal vegetation groundcover, extent of primary natural oyster colonization (red).

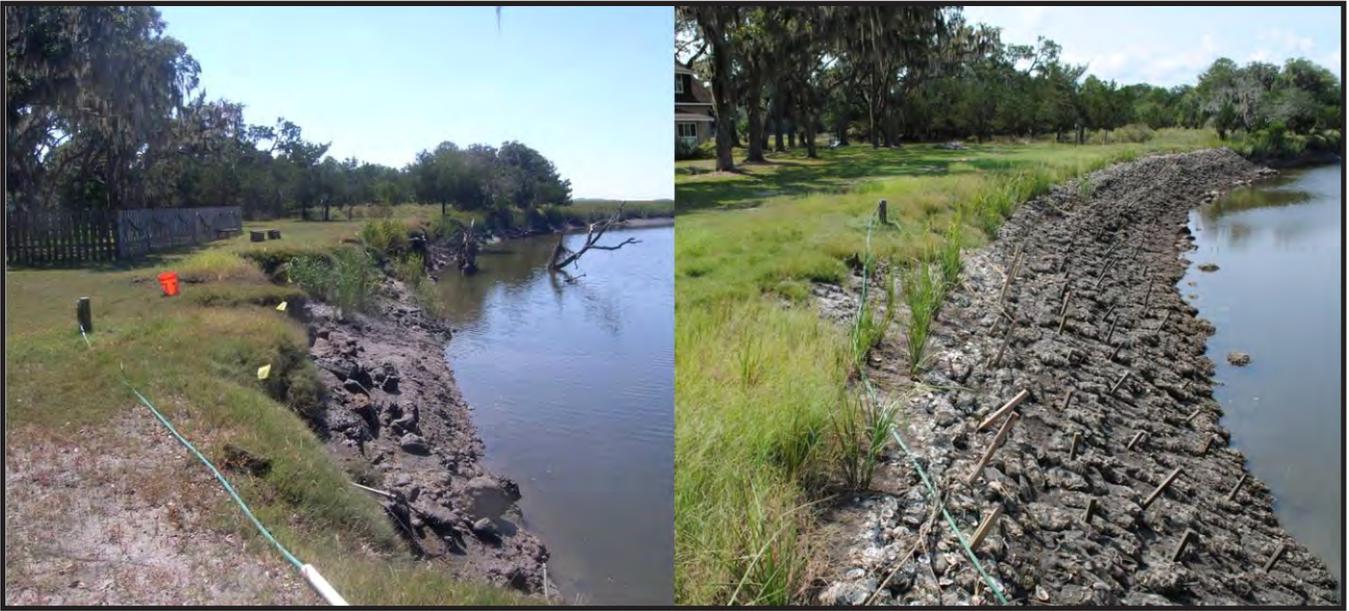
Ashantilly Living Shoreline pre-construction in 2009 (left) and post-construction in 2010 (right)

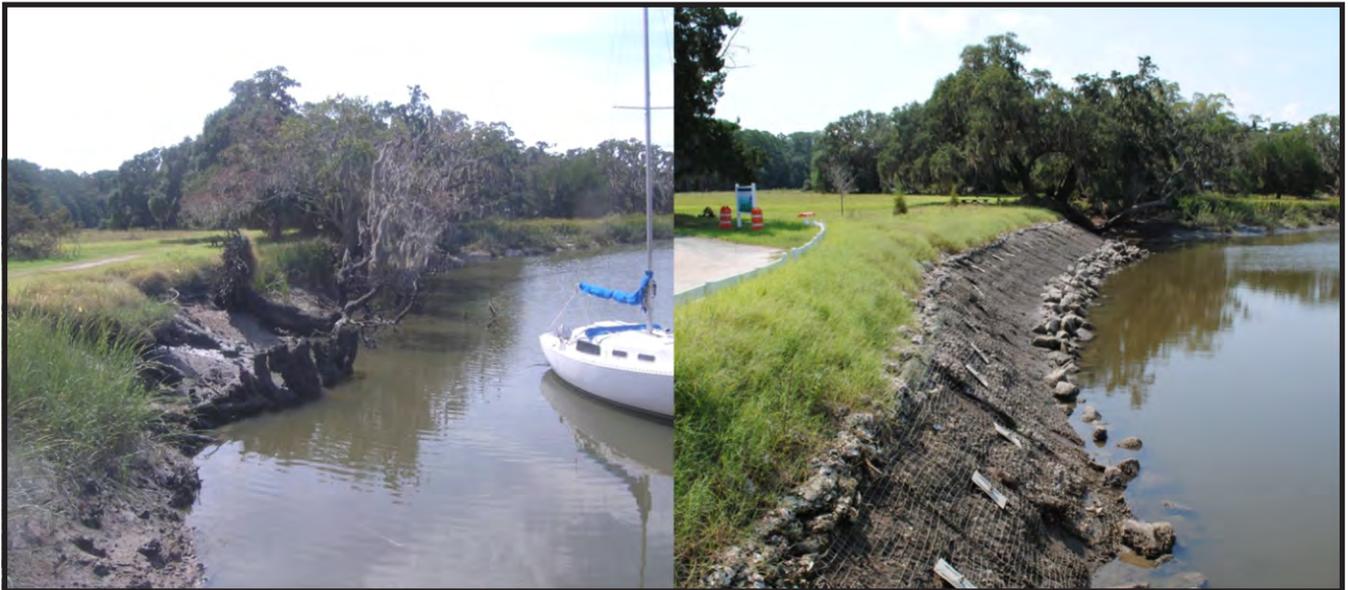
Long Tabby Living Shoreline pre-construction in 2009 (left) and post-construction in 2010 (right)

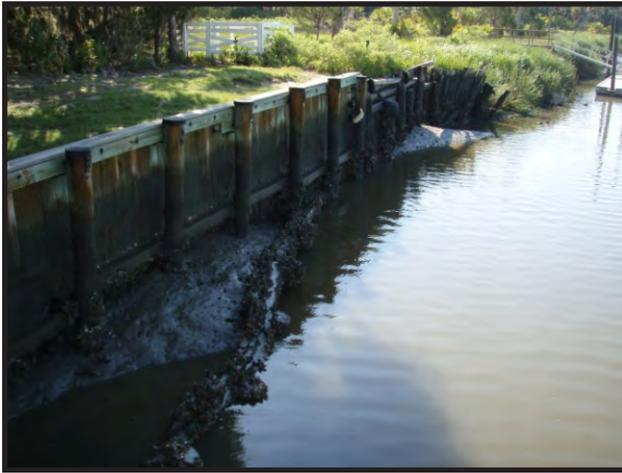
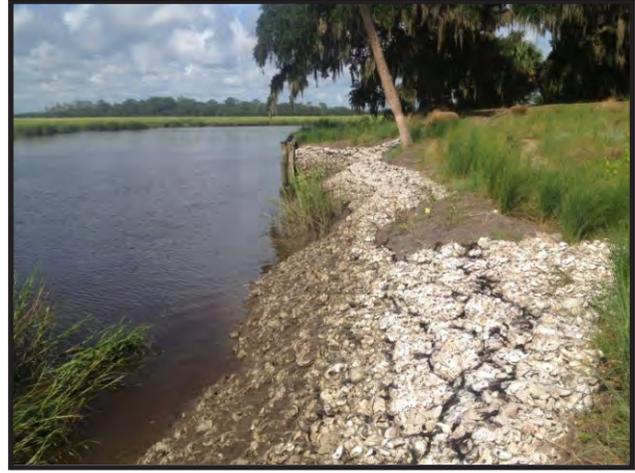
Little St. Simons Island shoreline progress 2012 (left) and 2013 (right)

Minor erosion occurred at the top of bank at LSSI, as it did at the Sapelo sites, due to rain and storm water runoff, but it was not extensive and was easily repaired. Additional oyster bags, soil, and erosion control blankets were placed and monitoring will continue. The potential for erosion of these areas should be eliminated as native plants and their root systems become more established. The plans specified the placement of bags up to 4.5' above mean tide on LSSI, which is 0.5' higher than the top of bags at Sapelo, but did not extend further in consideration of the planting designs. In future projects, oyster bags (or approved alternative) should be placed higher on the embankment and then covered with soils and plants and erosion control blankets as required. The additional bags, while ineffective as cultch material and invisible, would eliminate the potential for extensive gullies which could compromise the integrity of the bank from within.

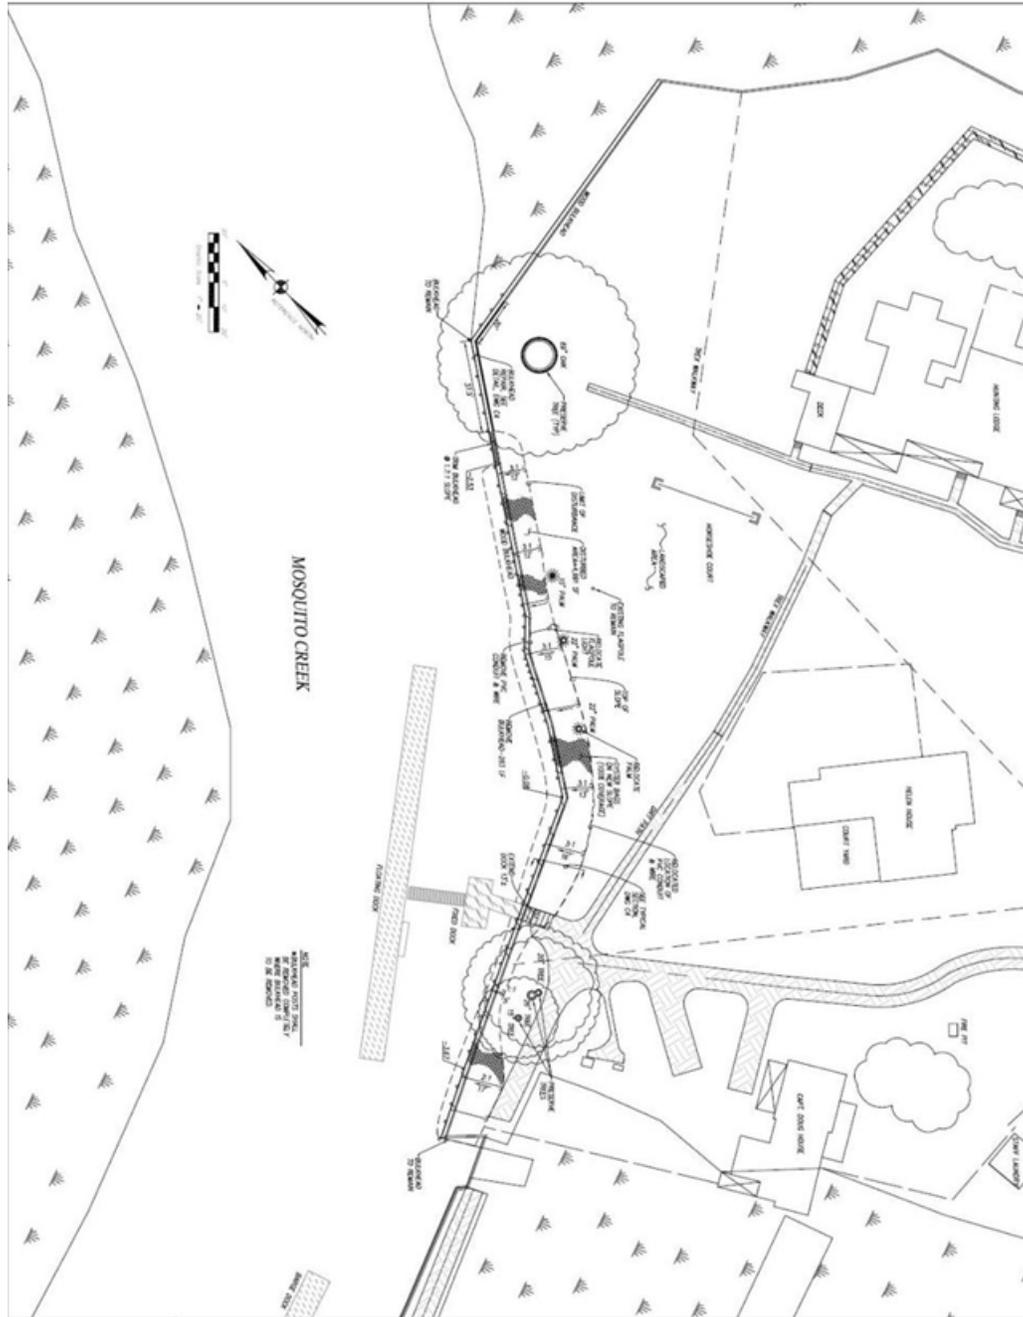
Living Shoreline Site Plan for Little St Simons Island

LITTLE ST. SIMON'S ISLAND
GEORGIA BARRIER ISLANDS, GLYNN COUNTY
LIVING SHORELINE SITE PLAN
