RE: Revised Application for Issuance of a Shore Protection Act Permit – East Beach Water Impoundment Project, Glynn County, Georgia

On behalf of the applicant, Glynn County Engineering Services, we are submitting this package including an application for a Shore Protection Act (SPA) permit to authorize improvements to impounded open water areas associated with construction of the East Beach Water Impoundment Project (the Project) located near Massengale Park on East Beach, St. Simons Island, Georgia.

The proposed public and community project consists of restoration and filling of an area of East Beach that has developed a tidal pool complex over the past several years that is currently an impounded open water area. The project would fill part of the impounded area while avoiding wetland impacts. Native sand would be harvested onsite to provide clean fill material. Refer to Attachment B for Project Plans.

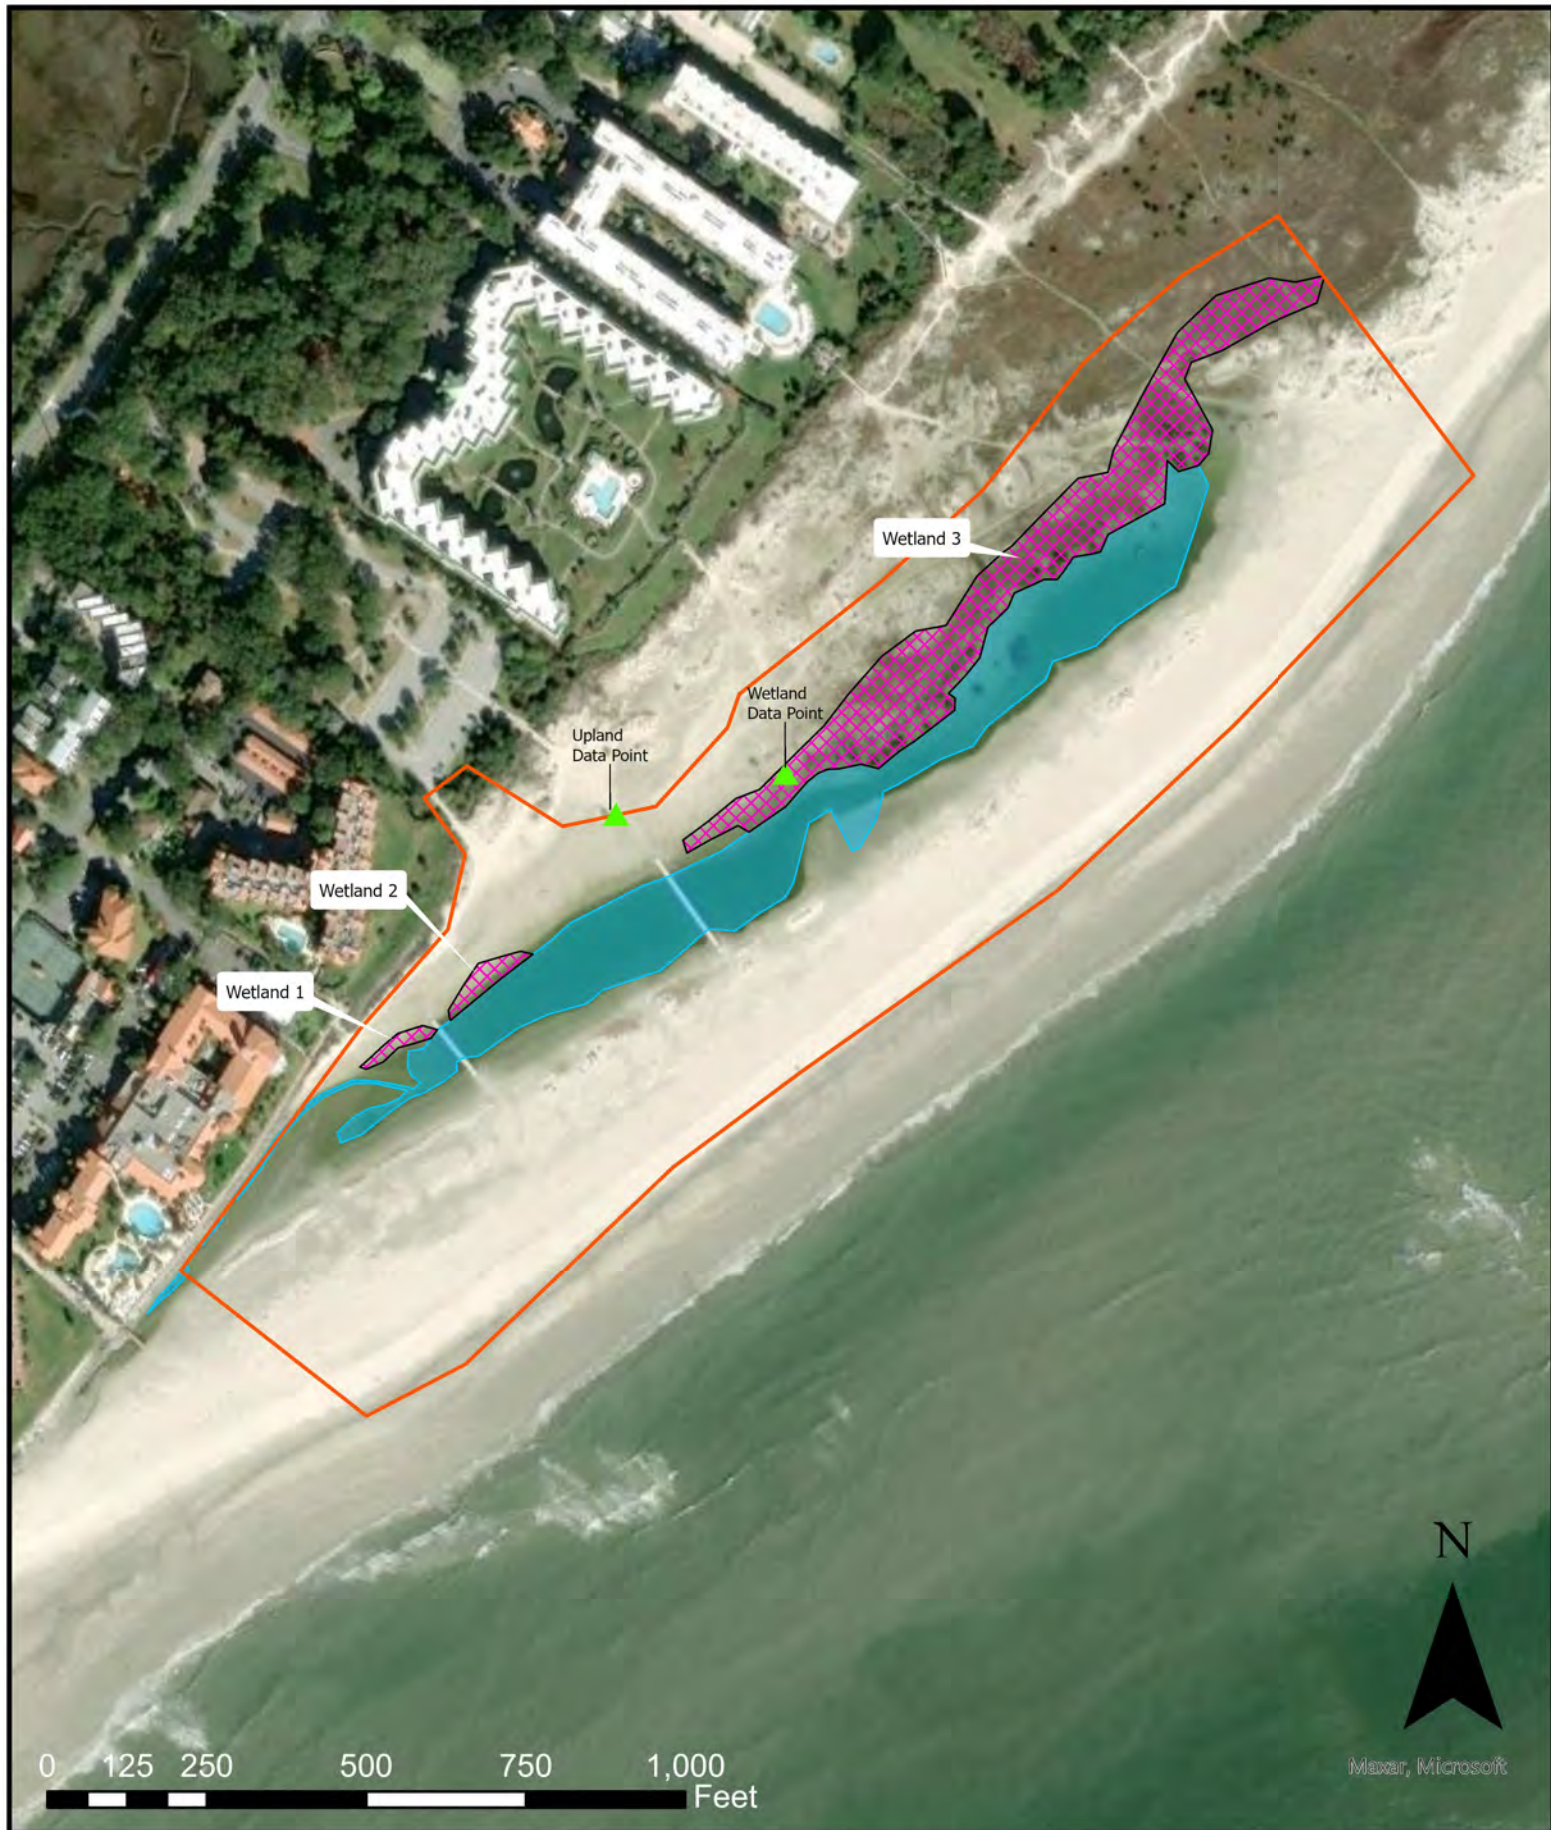
Figure 2: Wetlands and Waters Delineation Map  
East Beach Water Impoundment Project  
Glynn County, Georgia

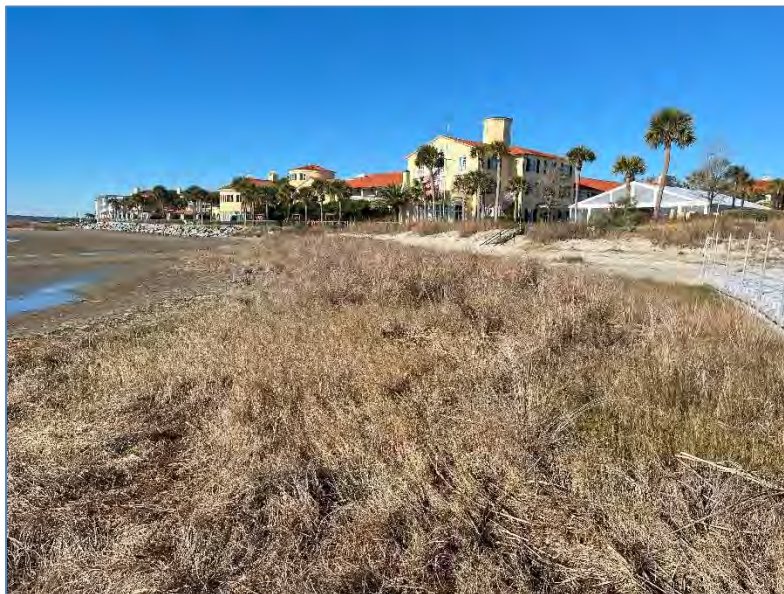
Wetland 1

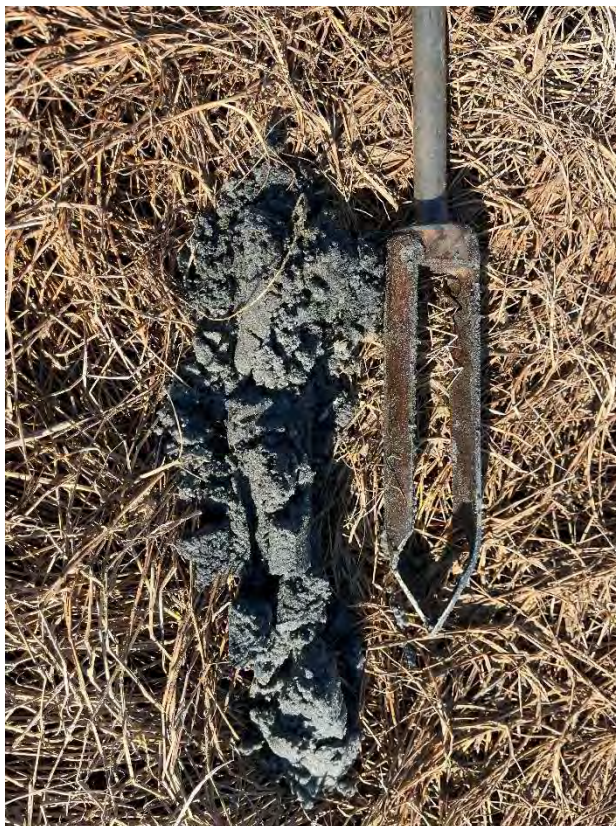
Wetlands 1 and 2 Soil

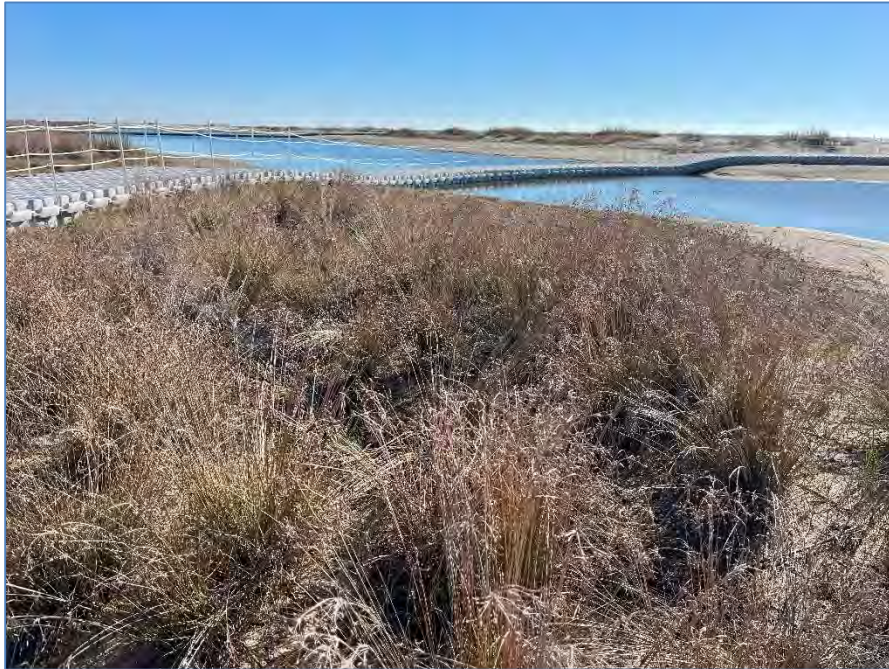
Wetlands 1 and 2

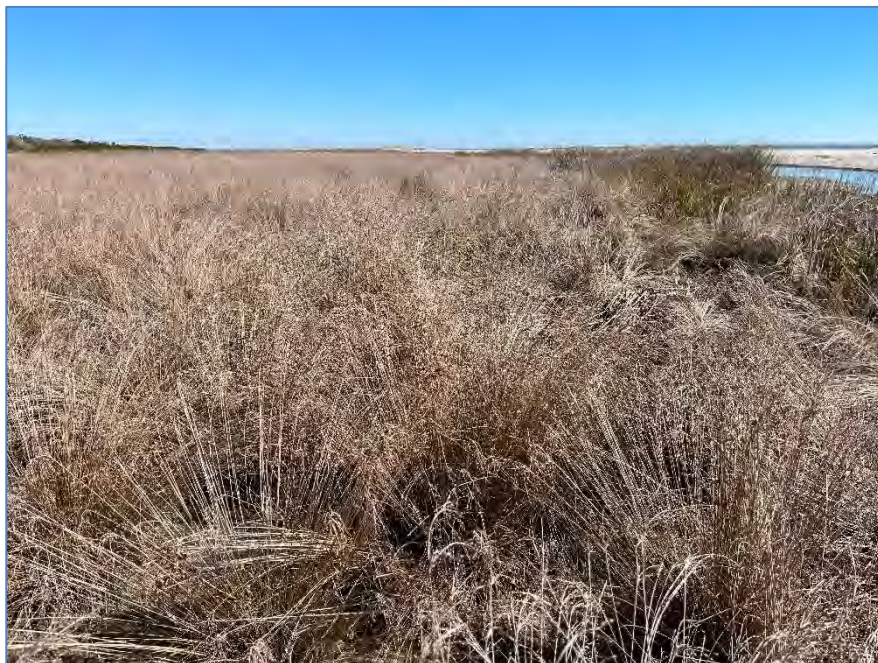
Wetland 3

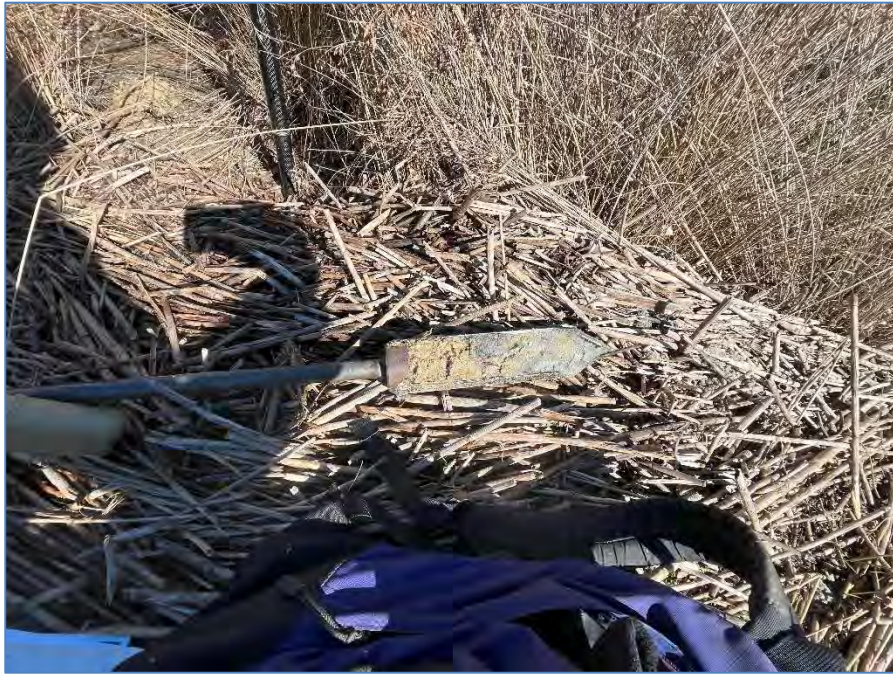
Wetland 3 Soil

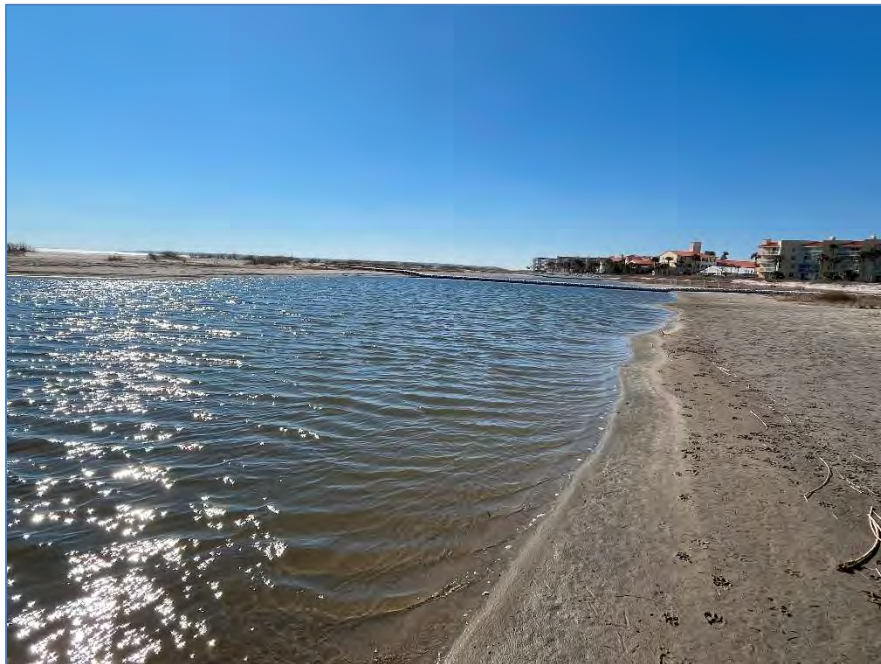
Water Impoundment 1

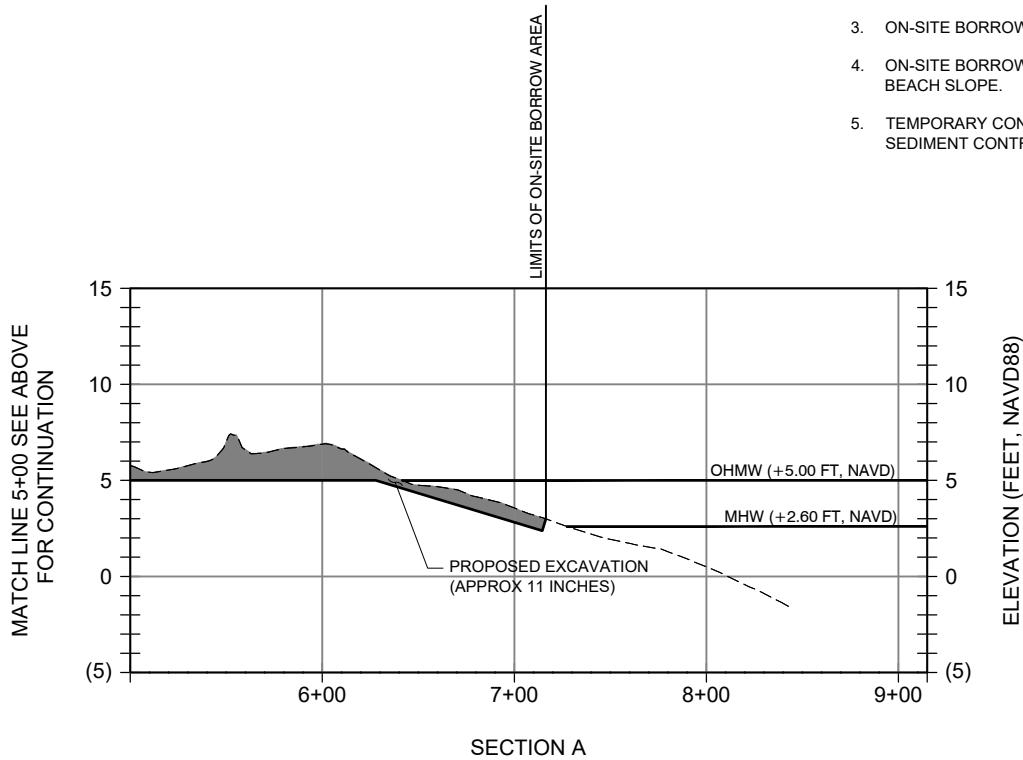
#### SECTION A

1. FILL MATERIAL TO BE EXCAVATED MATERIAL FROM THE ON-SITE BORROW AREA.
2. PROPOSED EXCAVATION SHALL BE LIMITED TO THE MINIMUM PRACTICABLE TO FILL IN EXISTING WATER IMPOUNDMENT AREA AND DUNE BREACH AREA.
3. ON-SITE BORROW TO OCCUR LANDWARD OF +3.00 FT NAVD.
4. ON-SITE BORROW AREA TO BE GRADED TO MATCH EXISTING BEACH SLOPE.
5. TEMPORARY CONSTRUCTION FENCE, SILT FENCE, AND OTHER SEDIMENT CONTROL MEASURES NOT SHOWN FOR CLARITY.

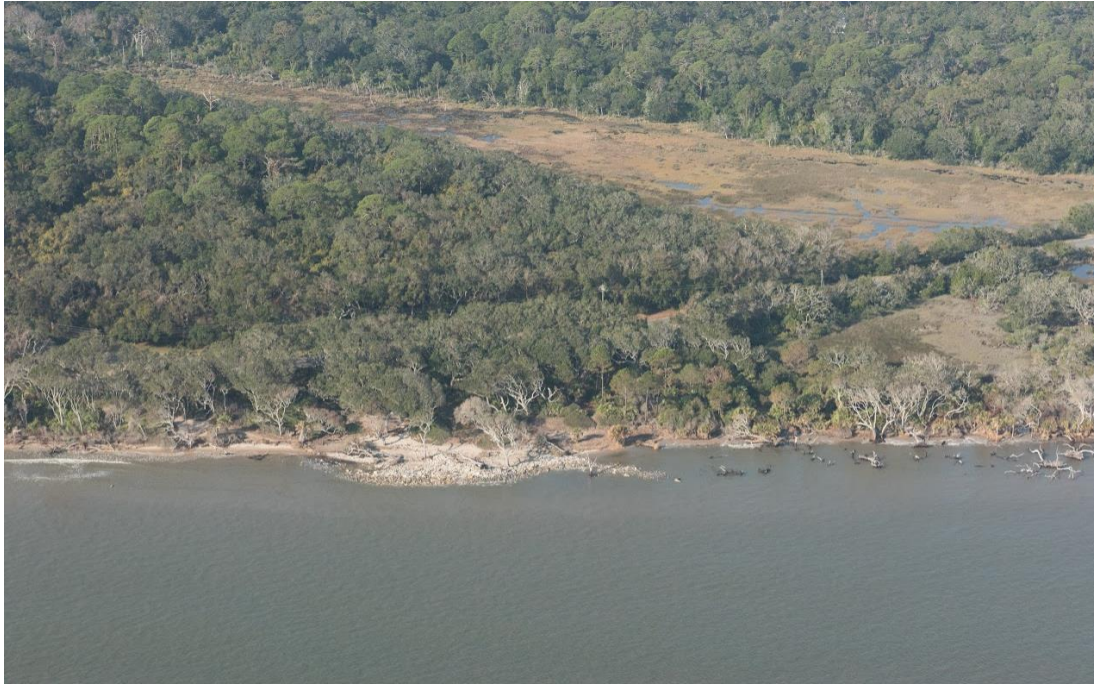
Exhibit 3. Eroded conditions north of existing revetment limits at Driftwood Beach during King tide conditions

The north tip of the island has undergone significant erosion and currently high-water conditions cut into the maritime forest in the Driftwood Beach area and north thereof (Exhibit 3). The northernmost approx. 9,800 LF of the revetment has undergone long-term general degradation due to settlement, beach erosion (profile deflation and erosion of fines) and overtopping and more direct damage during storm events.

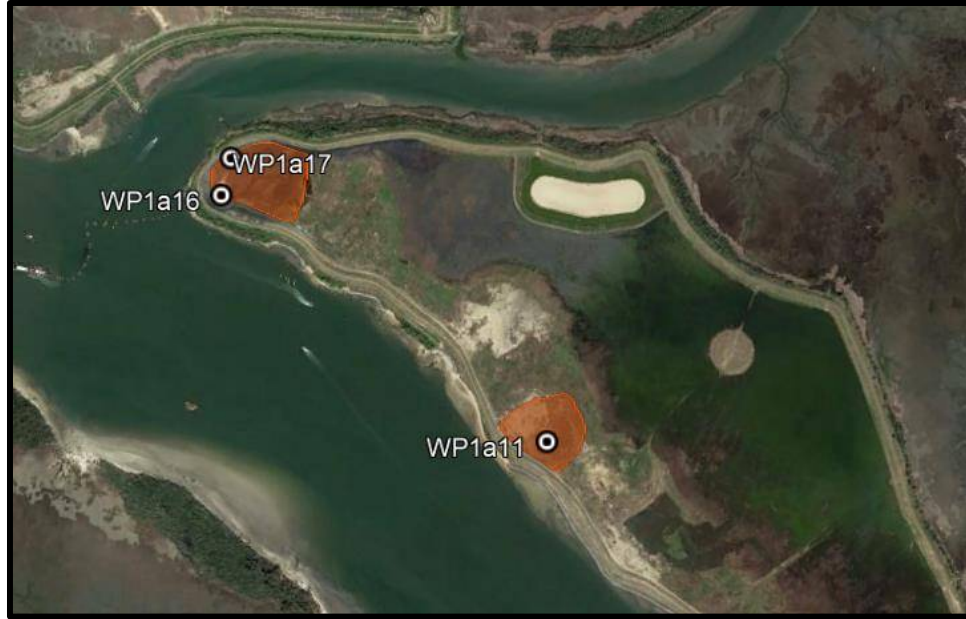
Figure 1. Jones Island Sand Material Areas and Test Sampling Locations

There is not a current detailed site topographic survey of the Jones Island site. However, ATM has estimated that approximately 175,000 CY of beach compatible material is available within the proposed two areas indicated on the Drawings. ATM’s volume estimate is based on site photographs, field GPS data, volume estimates from the recent dredge disposal operations, aerial imagery, and sediment sampling and testing. Height of sand material was determined by visual estimation of the existing surface elevation of the sand deposits and the USACE field representative’s description of elevations of the disposal area prior to the recent dredging operations. Representative observed sand material within the proposed borrow areas are illustrated in Photos 1-3.

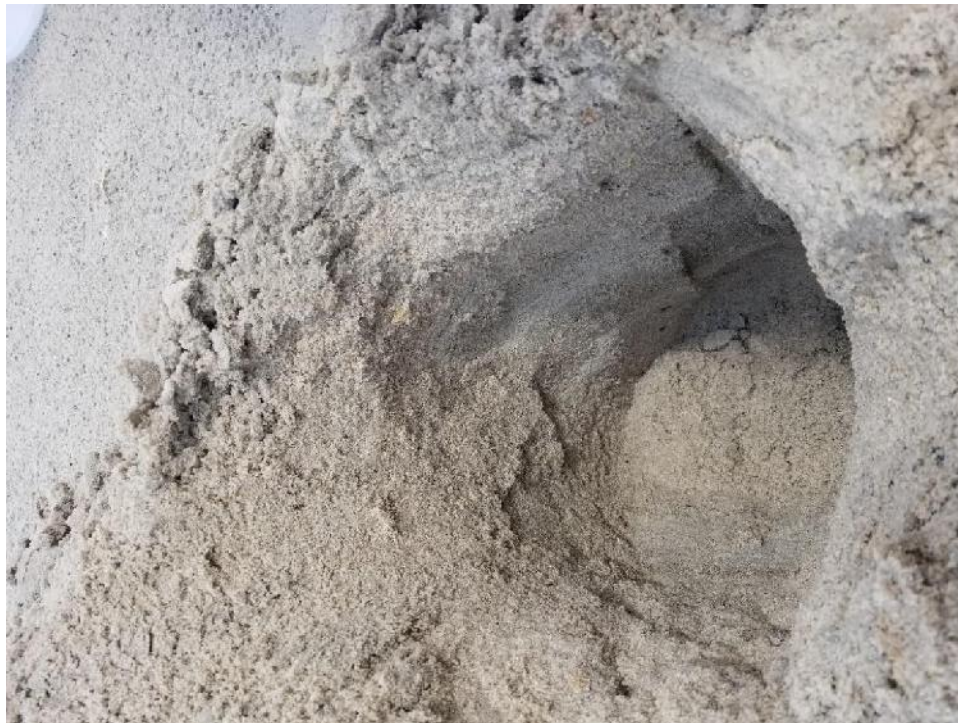
Photo 1 – Typical sediment sampling observations, Jones Island.

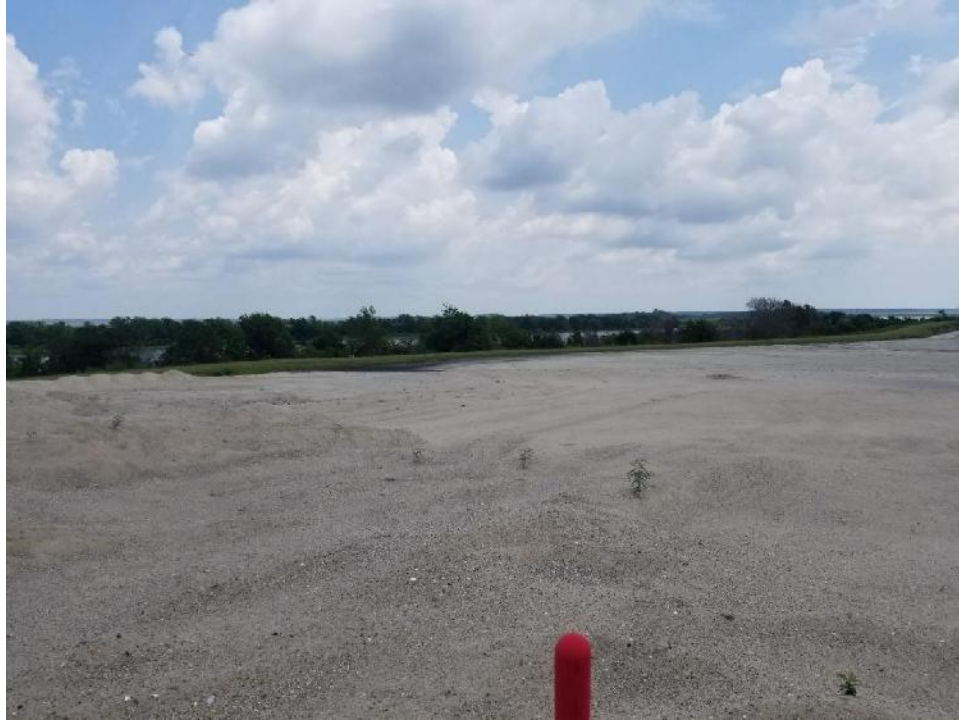
Photo 2 – Representative view of Jones Island borrow area.

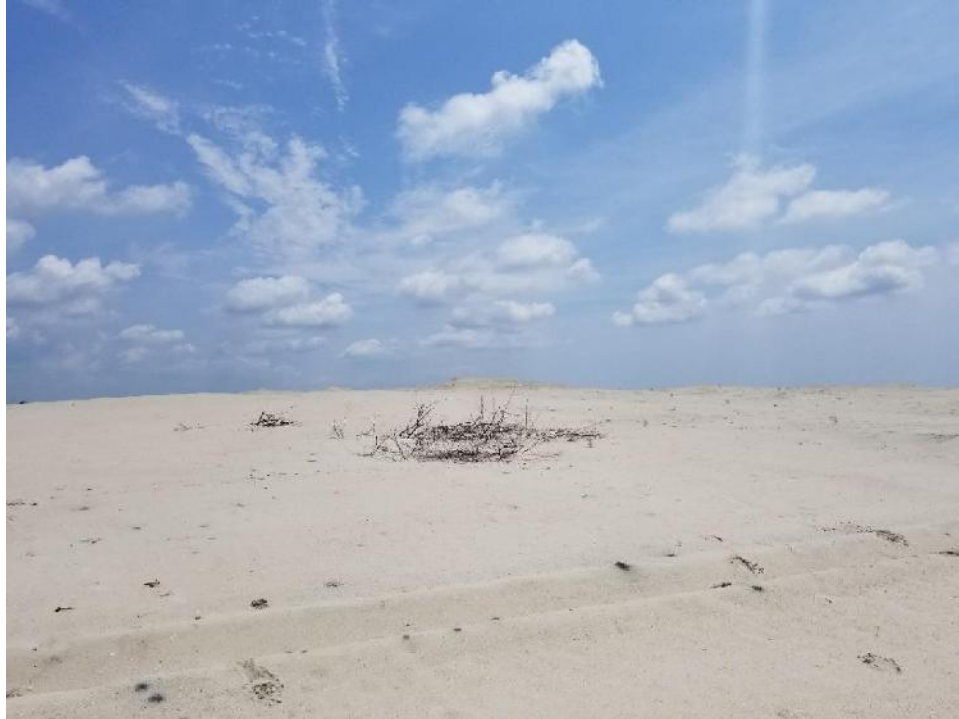
Photo 3 – Representative view of Jones Island borrow area.

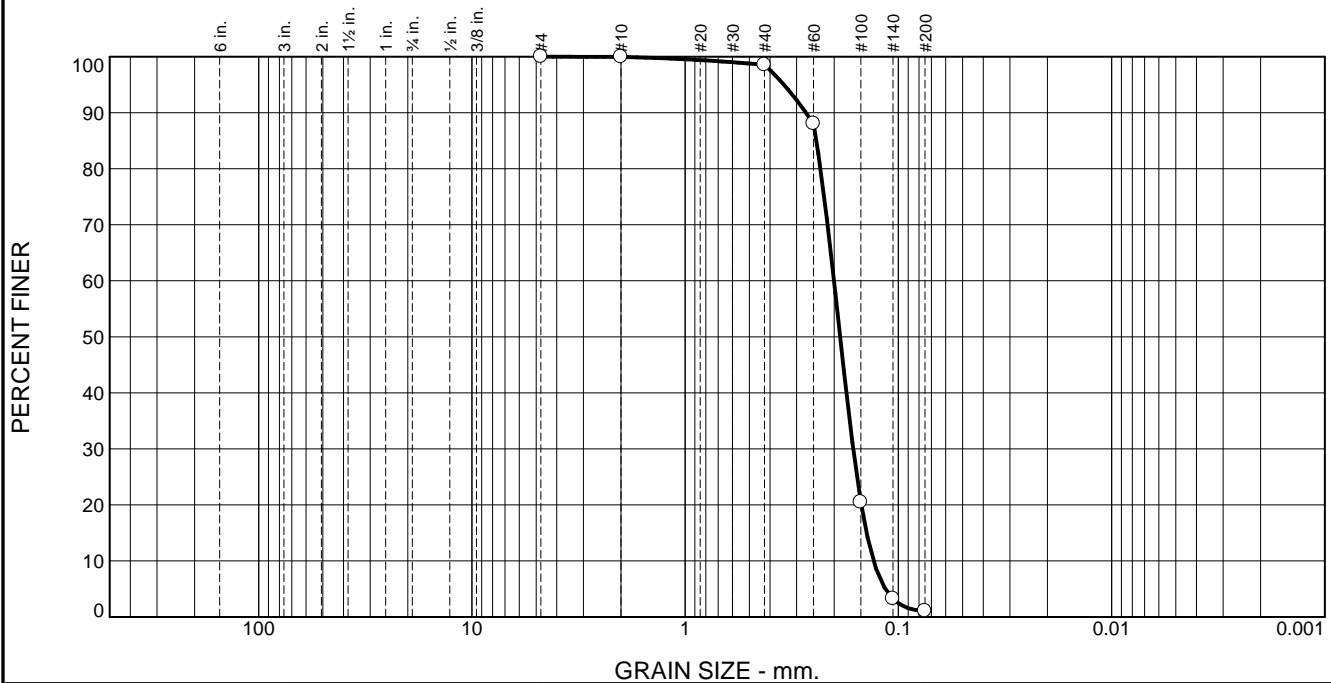
% +3"	% Gravel		% Sand			% Fines	
	Coarse	Fine	Coarse	Medium	Fine	Silt	Clay
0.0	0.0	0.0	0.0	1.4	97.5	1.1

TEST RESULTS			
Opening Size	Percent Finer	Spec.* (Percent)	Pass? (X=Fail)
#4	100.0		
#10	100.0		
#40	98.6		
#60	88.0		
#100	20.5		
#140	3.3		
#200	1.1

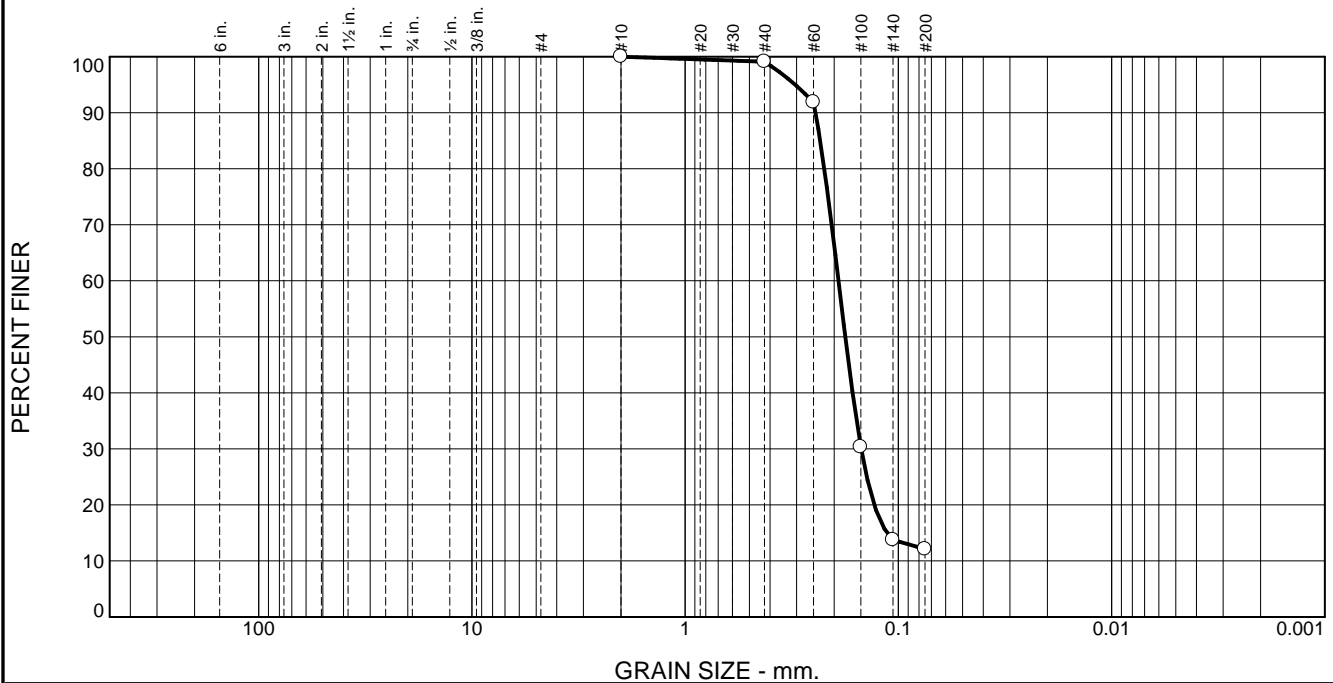
% +3"	% Gravel		% Sand			% Fines	
	Coarse	Fine	Coarse	Medium	Fine	Silt	Clay
0.0	0.0	0.0	0.0	0.9	87.0	12.1

TEST RESULTS			
Opening Size	Percent Finer	Spec.* (Percent)	Pass? (X=Fail)
#10	100.0		
#40	99.1		
#60	91.9		
#100	30.3		
#140	13.7		
#200	12.1

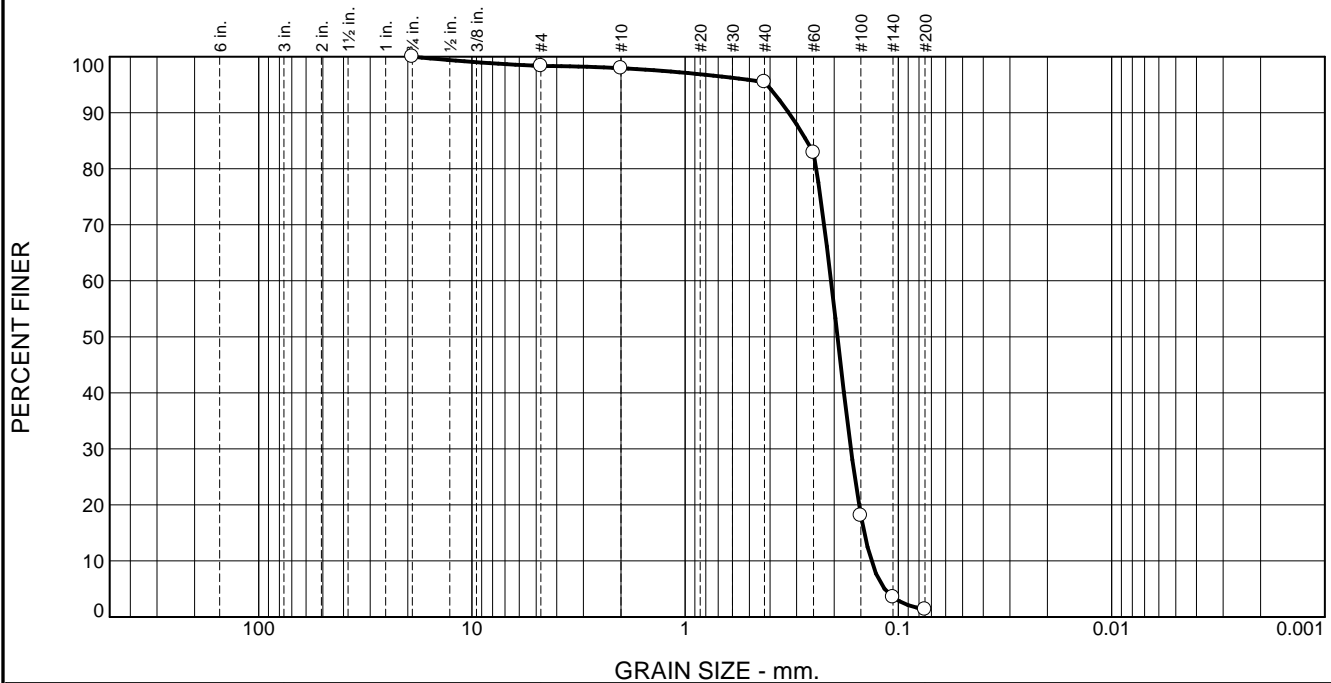
% +3"	% Gravel		% Sand			% Fines	
	Coarse	Fine	Coarse	Medium	Fine	Silt	Clay
0.0	0.0	1.7	0.4	2.4	94.1	1.4

TEST RESULTS			
Opening Size	Percent Finer	Spec.* (Percent)	Pass? (X=Fail)
3/4"	100.0		
#4	98.3		
#10	97.9		
#40	95.5		
#60	82.9		
#100	18.1		
#140	3.5		
#200	1.4

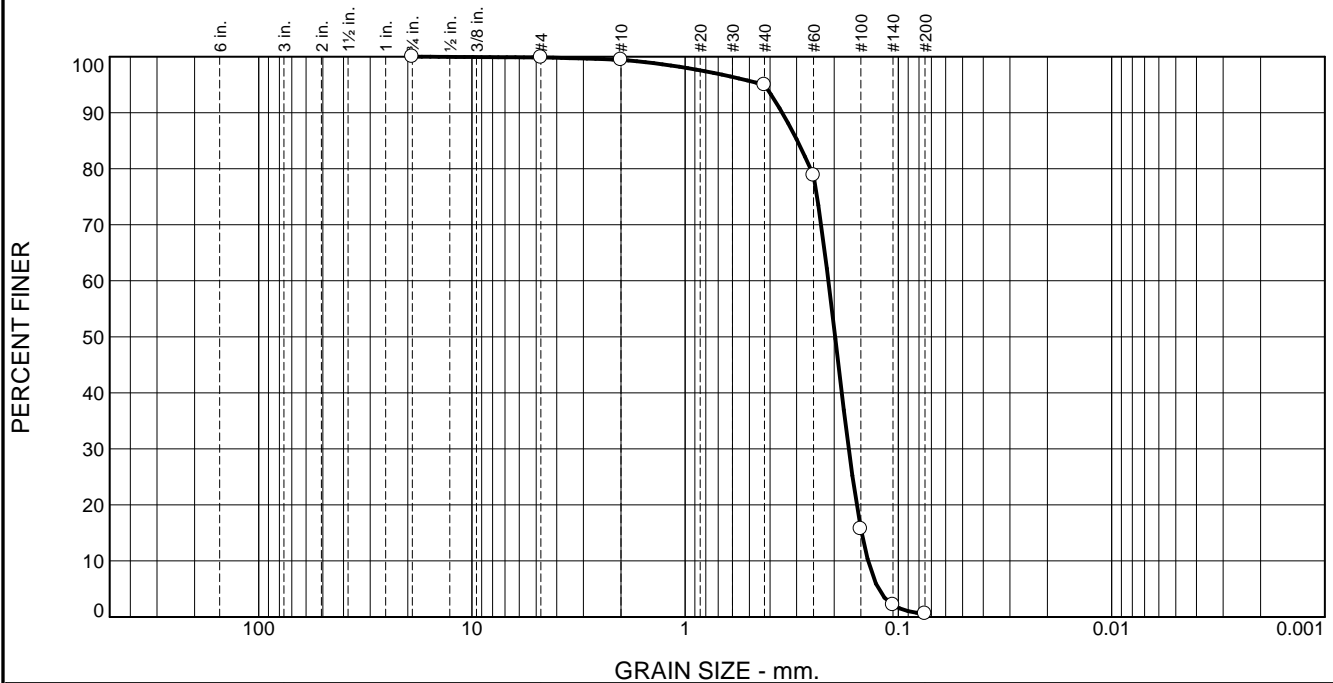
% +3"	% Gravel		% Sand			% Fines	
	Coarse	Fine	Coarse	Medium	Fine	Silt	Clay
0.0	0.0	0.1	0.5	4.4	94.4	0.6

TEST RESULTS			
Opening Size	Percent Finer	Spec.* (Percent)	Pass? (X=Fail)
3/4"	100.0		
#4	99.9		
#10	99.4		
#40	95.0		
#60	78.8		
#100	15.7		
#140	2.2		
#200	0.6

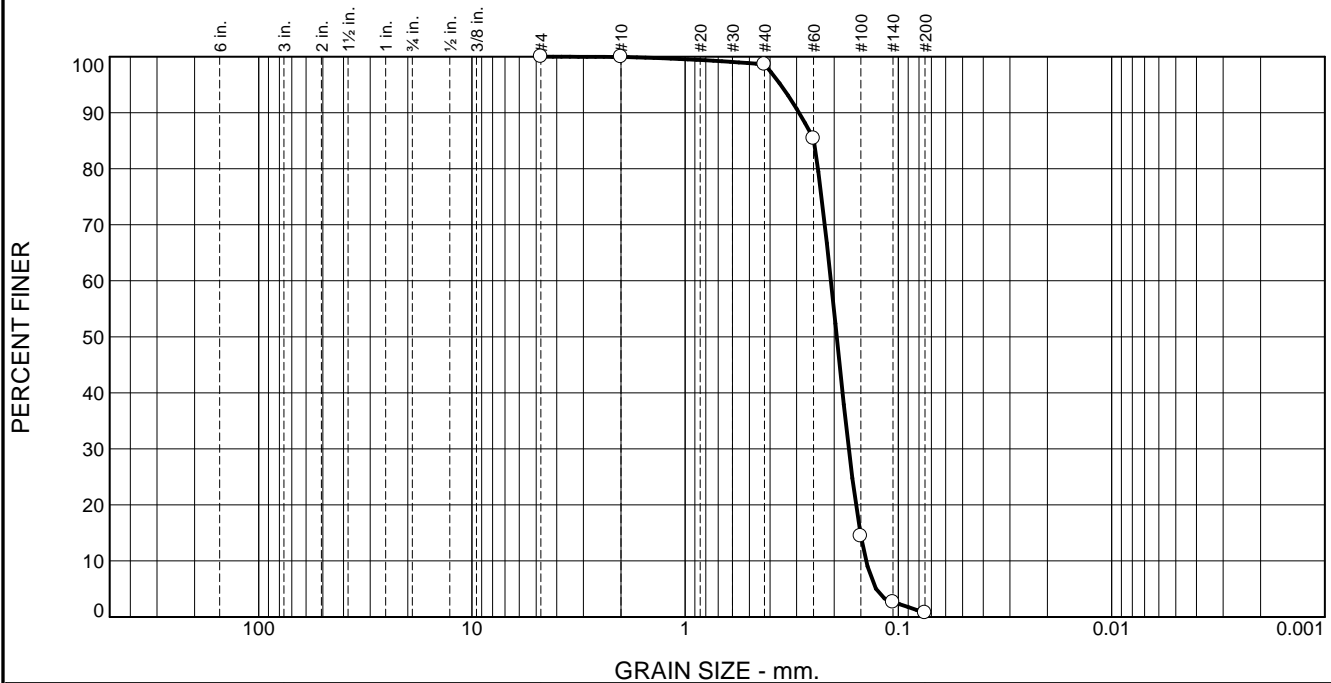
% +3"	% Gravel		% Sand			% Fines	
	Coarse	Fine	Coarse	Medium	Fine	Silt	Clay
0.0	0.0	0.0	0.1	1.3	97.9	0.7

TEST RESULTS			
Opening Size	Percent Finer	Spec.* (Percent)	Pass? (X=Fail)
#4	100.0		
#10	99.9		
#40	98.6		
#60	85.4		
#100	14.4		
#140	2.6		
#200	0.7

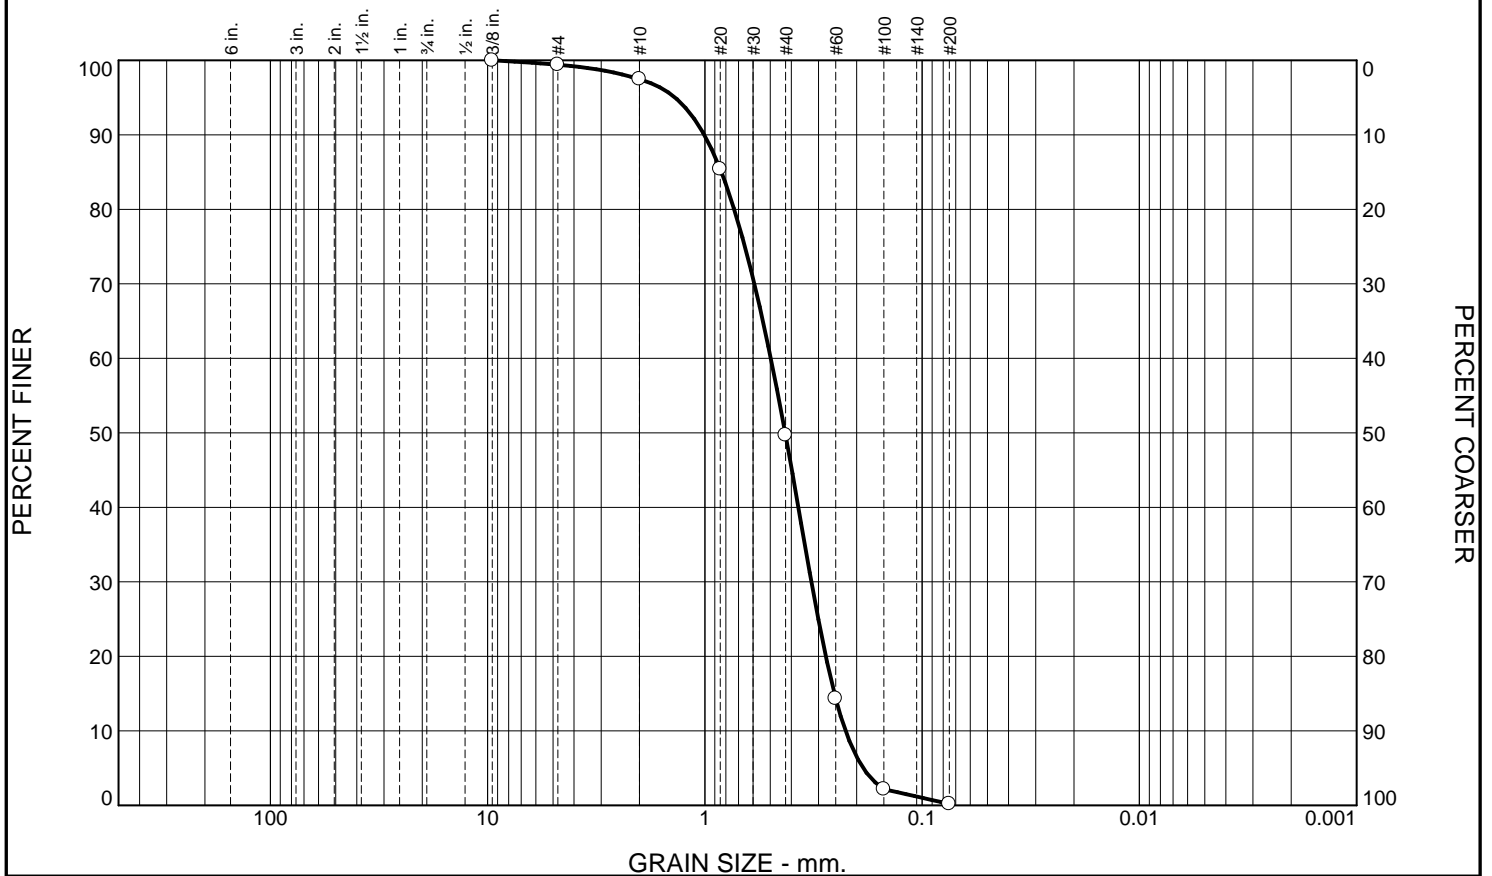
% +3"	% Gravel		% Sand			% Fines	
	Coarse	Fine	Coarse	Medium	Fine	Silt	Clay
0.0	0.0	0.6	1.9	47.8	49.5	0.2

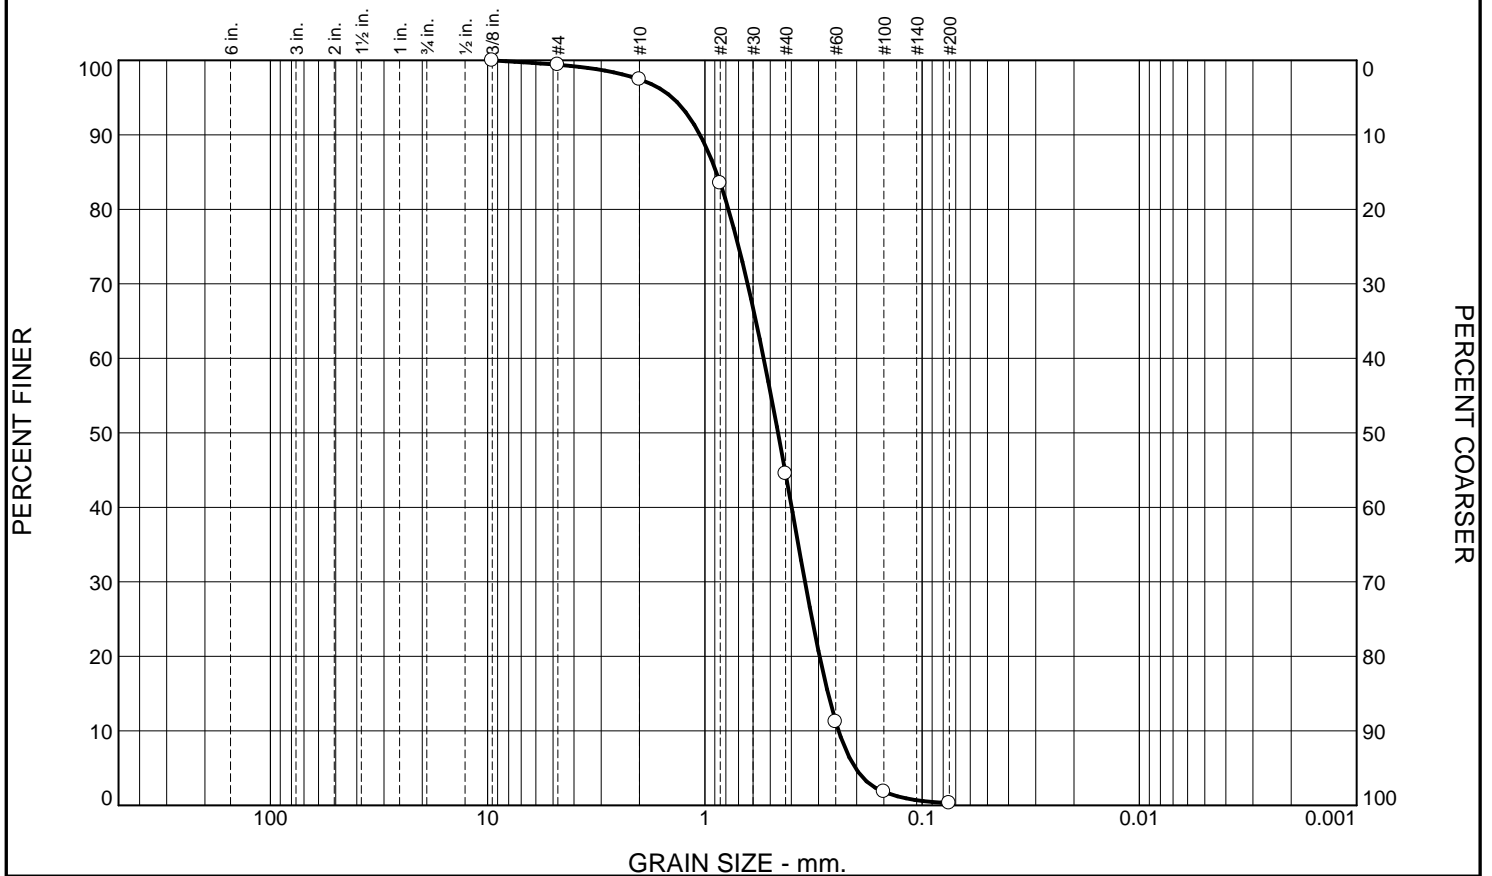
% +3"	% Gravel		% Sand			% Fines	
	Coarse	Fine	Coarse	Medium	Fine	Silt	Clay
0.0	0.0	0.6	2.0	52.9	44.2	0.3

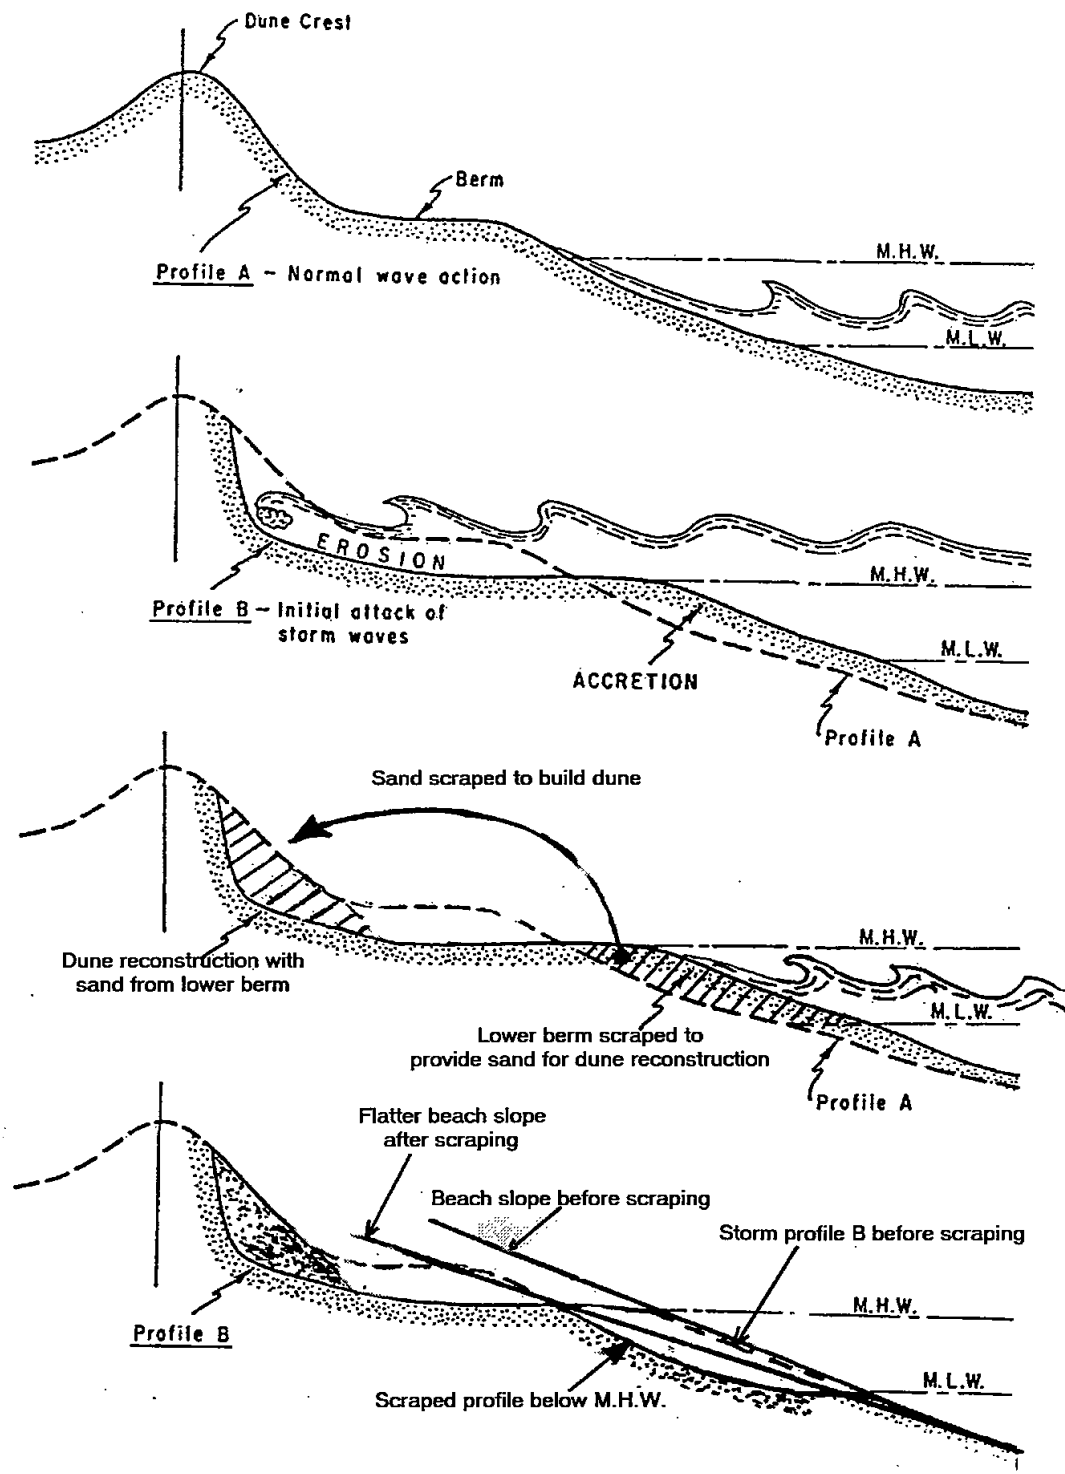
Figure 1: Beach scraping concept (Source: Lex Nielsen)

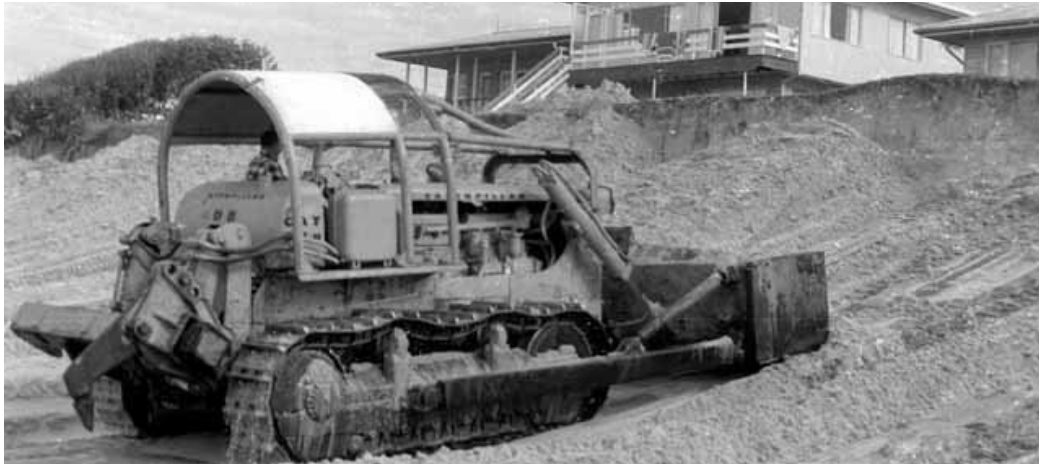
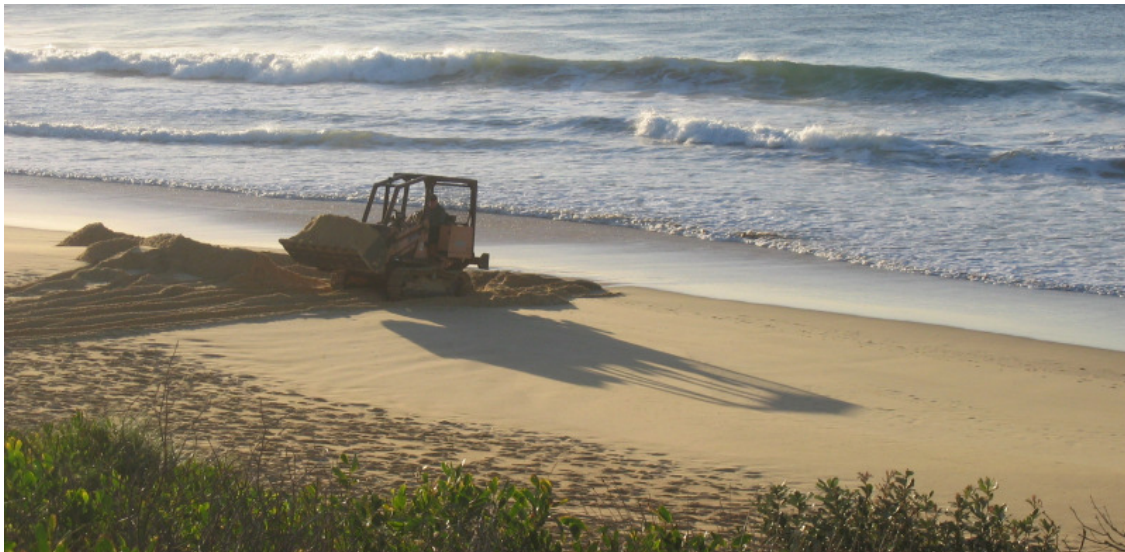
**Figure 2: Photos of beach scraping**

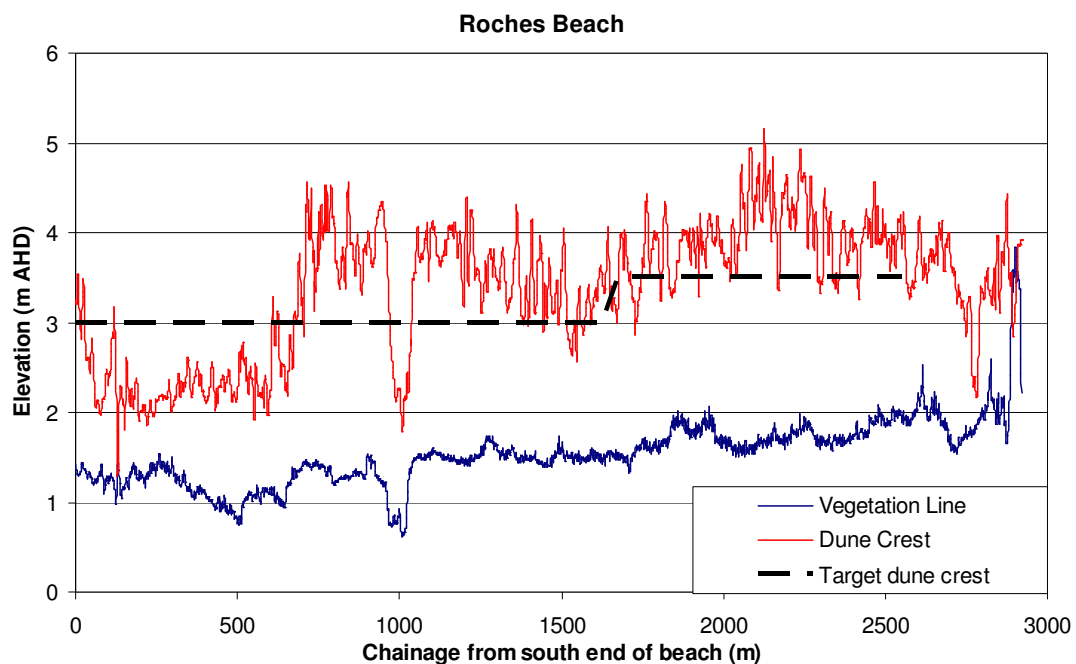
**Figure 3: Dune crest level versus design wave runup level**

An example of dune crest levels relative to design wave runup (indicated as “target dune crest level”) is shown in Figure 3. Beach scraping may be feasible for raising the crest of dune areas with a crest below the runup level, to prevent dune overwash.

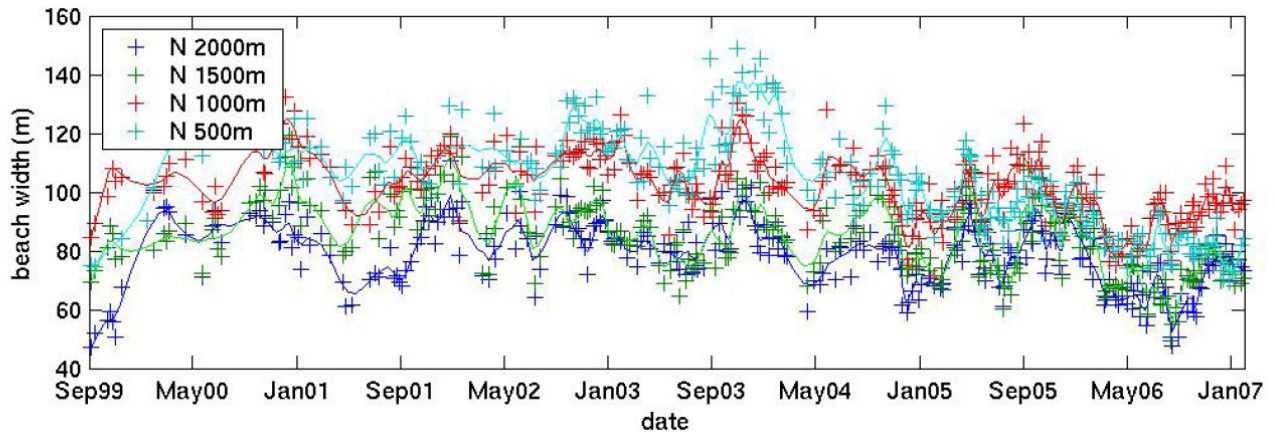
**Figure 4: Seasonal change in beach width on northern Gold Coast (Blacka et al 2007)**

An example of quasi-seasonal changes in beach width is shown in Figure 4. This figure (from Blacka et al, 2007) shows beach width on the northern Gold Coast. The beach width generally increased in spring and decreased during the first half of the year. Similar patterns are likely to occur in northern NSW.
