RE: Revised Application for Issuance of a Shore Protection Act Permit – East Beach Water Impoundment Project, Glynn County, Georgia

On behalf of the applicant, Glynn County Engineering Services, we are submitting this package including an application for a Shore Protection Act (SPA) permit to authorize improvements to impounded open water areas associated with construction of the East Beach Water Impoundment Project (the Project) located near Massengale Park on East Beach, St. Simons Island, Georgia.

The proposed public and community project consists of restoration and filling of an area of East Beach that has developed a tidal pool complex over the past several years that is currently an impounded open water area. The project would fill part of the impounded area while avoiding wetland impacts. Native sand would be harvested onsite to provide clean fill material. Refer to Attachment B for Project Plans.

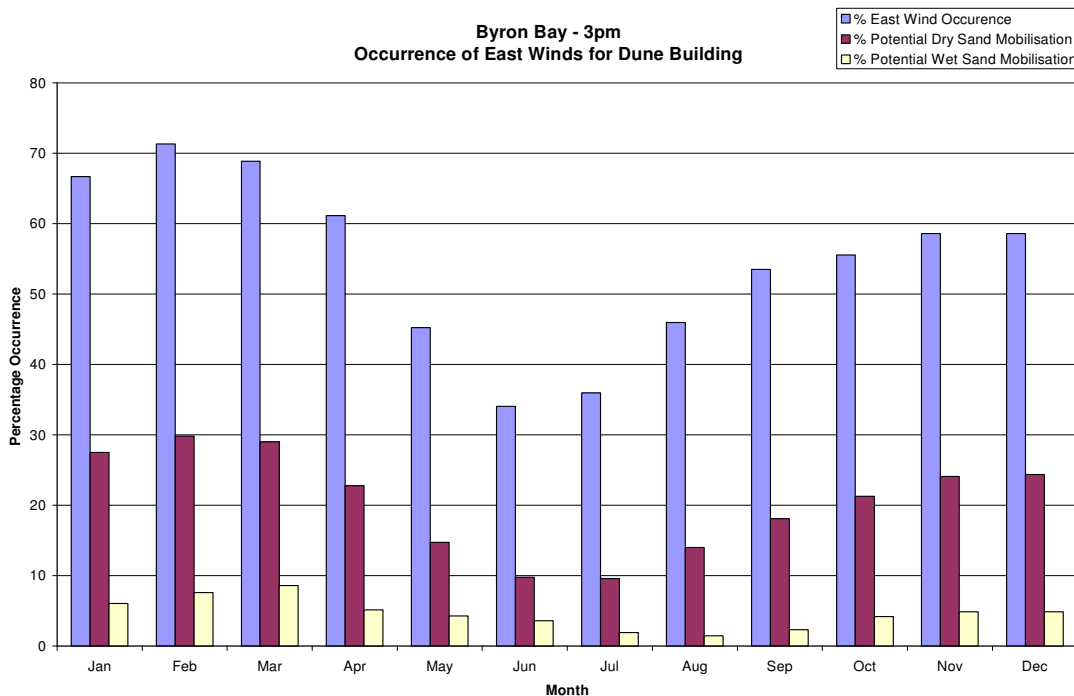
**Figure 5: Seasonal winds (3 PM) favourable to dune building (Cape Byron data)**

The large difference in motion threshold between wet and dry sand shows the sensitivity to location on the beach face and tidal water level, as well as changes in rainfall, which may be due to natural variability, seasonality, cyclic patterns (el niño-southern oscillation and inter-decadal Pacific oscillation) and climate change. A plot (from Cape Byron) of the seasonal occurrence of winds at 3 PM which are favourable for dune building is shown in Figure 5. This plot shows that dune building through wind is least prevalent from May to August.
