**Subject: Committee Request for Additional Information  
Polk Street Maintenance  
Chatham County, Georgia**

**RLC# 08-028**

**BOUNDARY & TOPOGRAPHICAL SURVEY OF A PORTION OF POLK STREET SOUTH OF U.S. HIGHWAY 80, LOCATED IN GARDEN WARD, TYBEE ISLAND, GEORGIA.**

A previous study was conducted in 2014 by NAI as documented in Technical Memorandum 13-079.01 with subject "Hydrological and ecological assessment of proposed Polk Street maintenance project, City of Tybee Island, Georgia." The December 2021 motion requested the previous study be updated to ensure the analysis reflects current site conditions following recent hurricane activity and adequately evaluates the project's potential to affect the surrounding salt marsh and aquatic ecosystem.

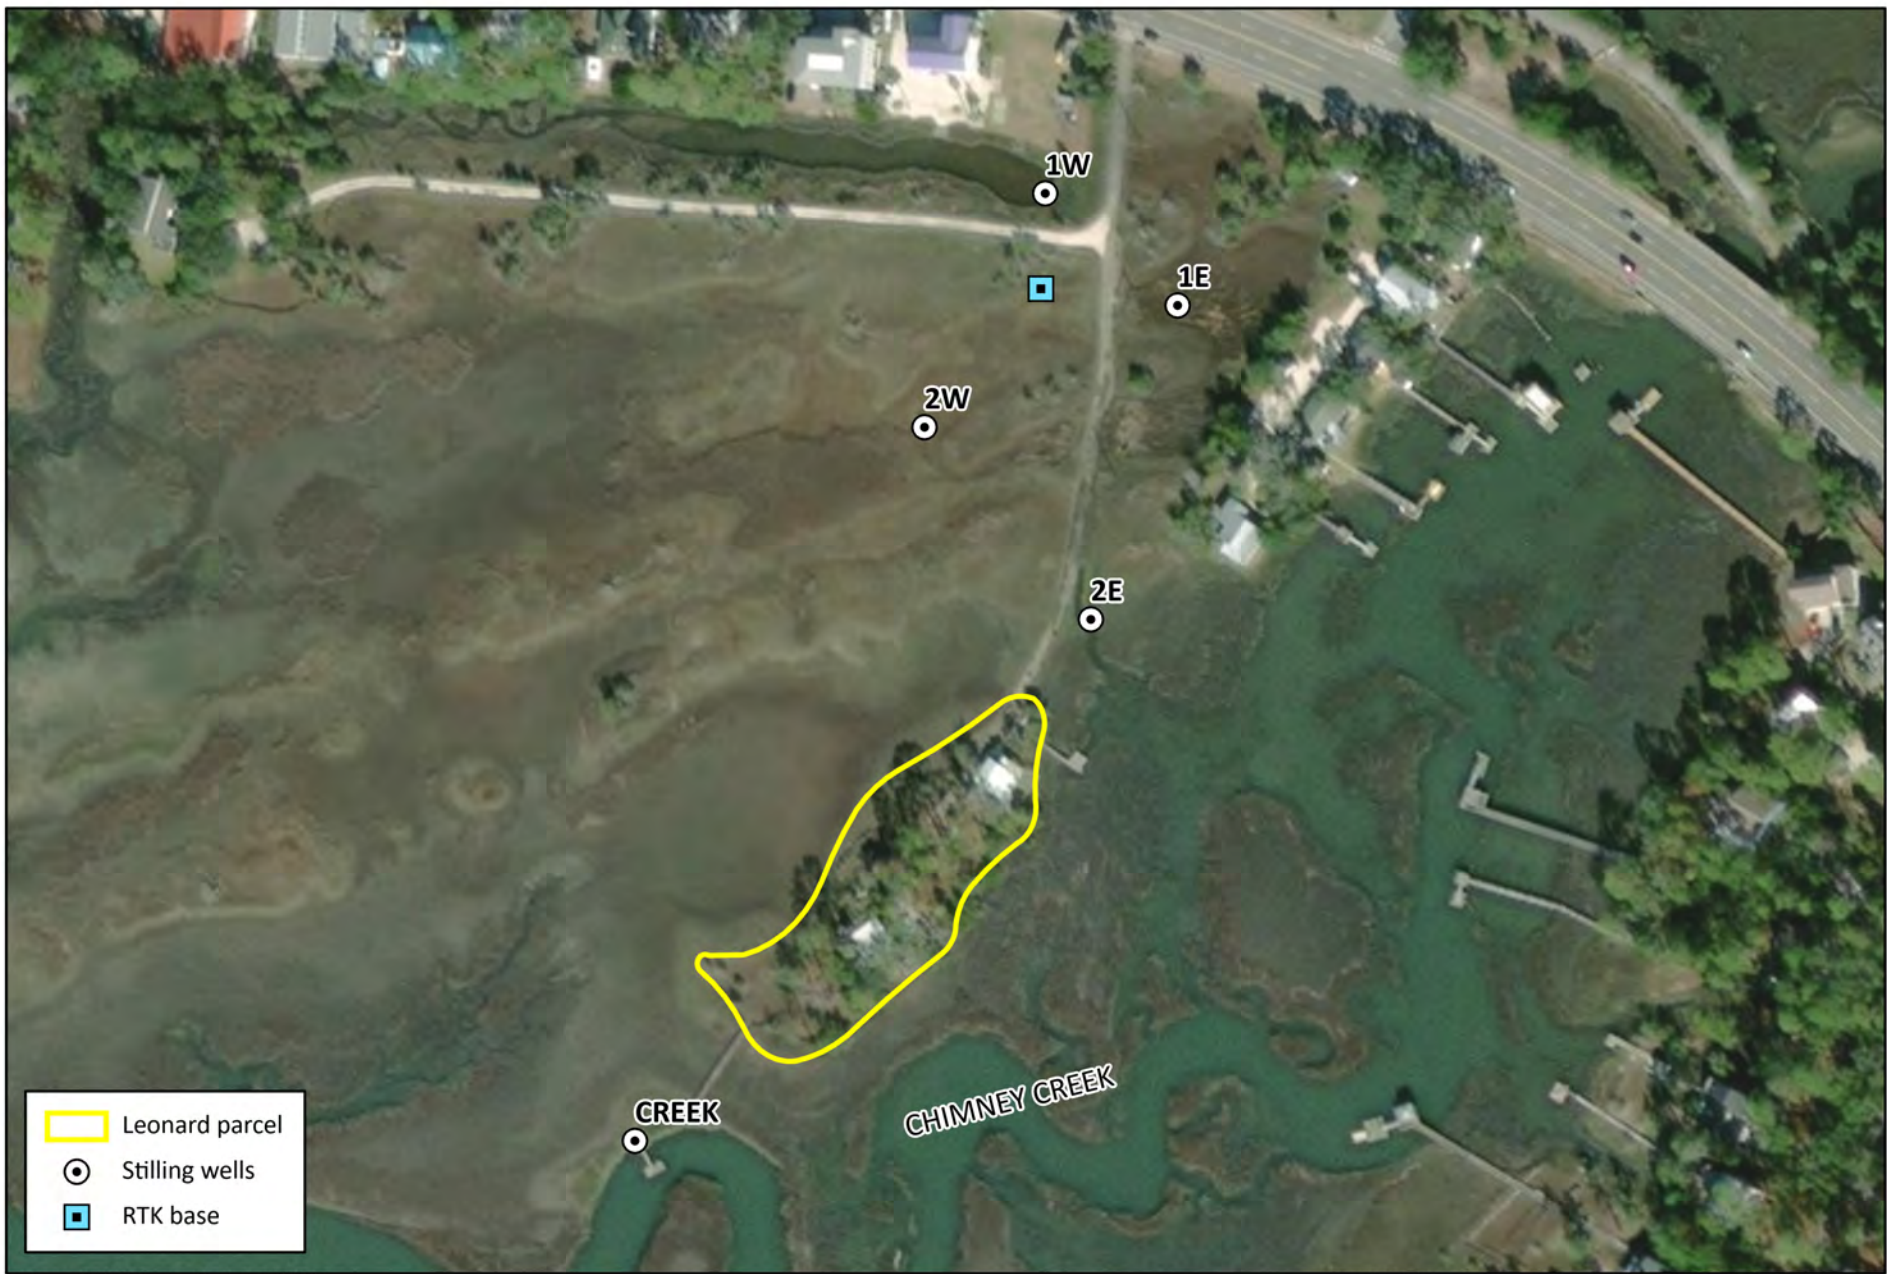
Figure 2. Stilling well locations and RTK base station within the vicinity of the Polk Street study area.

A Nikon Total Station® was used to survey elevations for each stilling well, the salt marsh ground surface and the roadway surface. A survey-grade real-time kinematic (RTK) GPS was used to survey a fixed point within the project area to convert relative water levels to a vertical datum (NGVD29) to allow comparison of water surface elevations. Visual observations of site conditions, hydrological dynamics and ecological characteristics were documented within and around the project area during high and low tide.

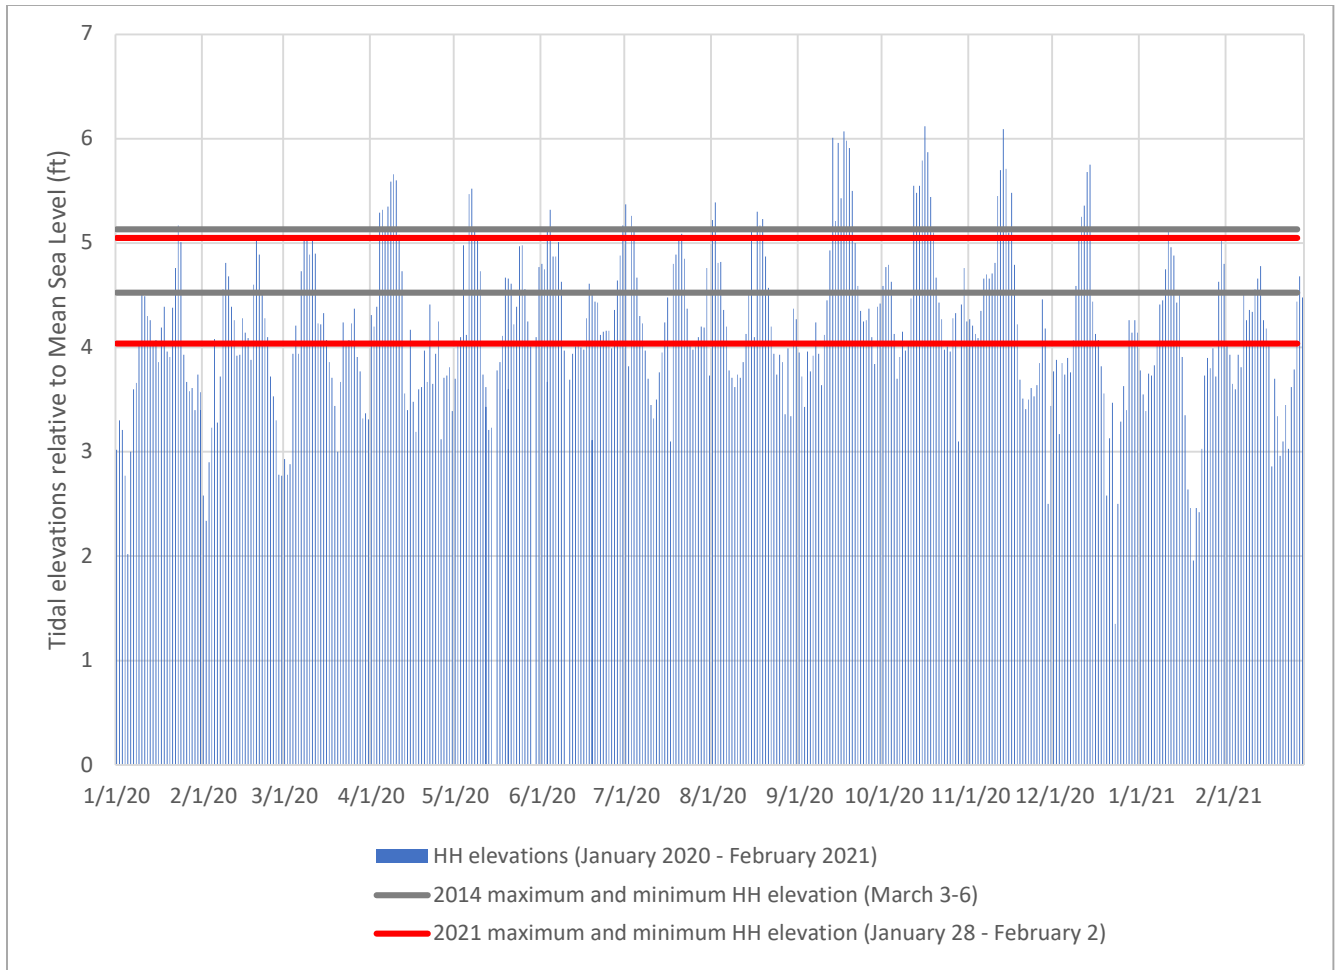
Figure 3. Minimum and maximum HH tides measured at the NOAA Fort Pulaski, Georgia tide gage (Station ID 8670870) during the 2021 data collection period relative to daily HH tide elevations measured in the 14-month period (January 2020 to February 2021) prior to data collection. Minimum and maximum HH tides from the 2014 study are shown in gray for reference.

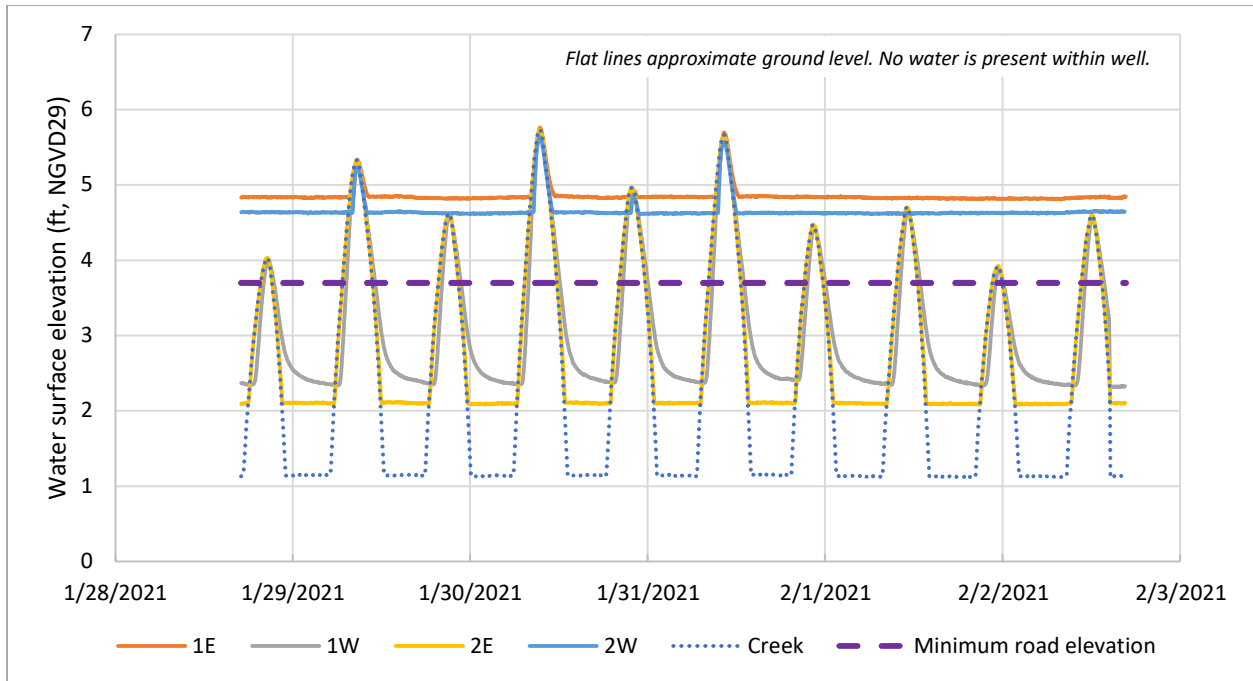
Figure 5. Water surface elevations recorded at Well 1E, 1W, 2E, 2W, and Creek from January 28<sup>th</sup>, 2021 to February 2<sup>nd</sup>, 2021.

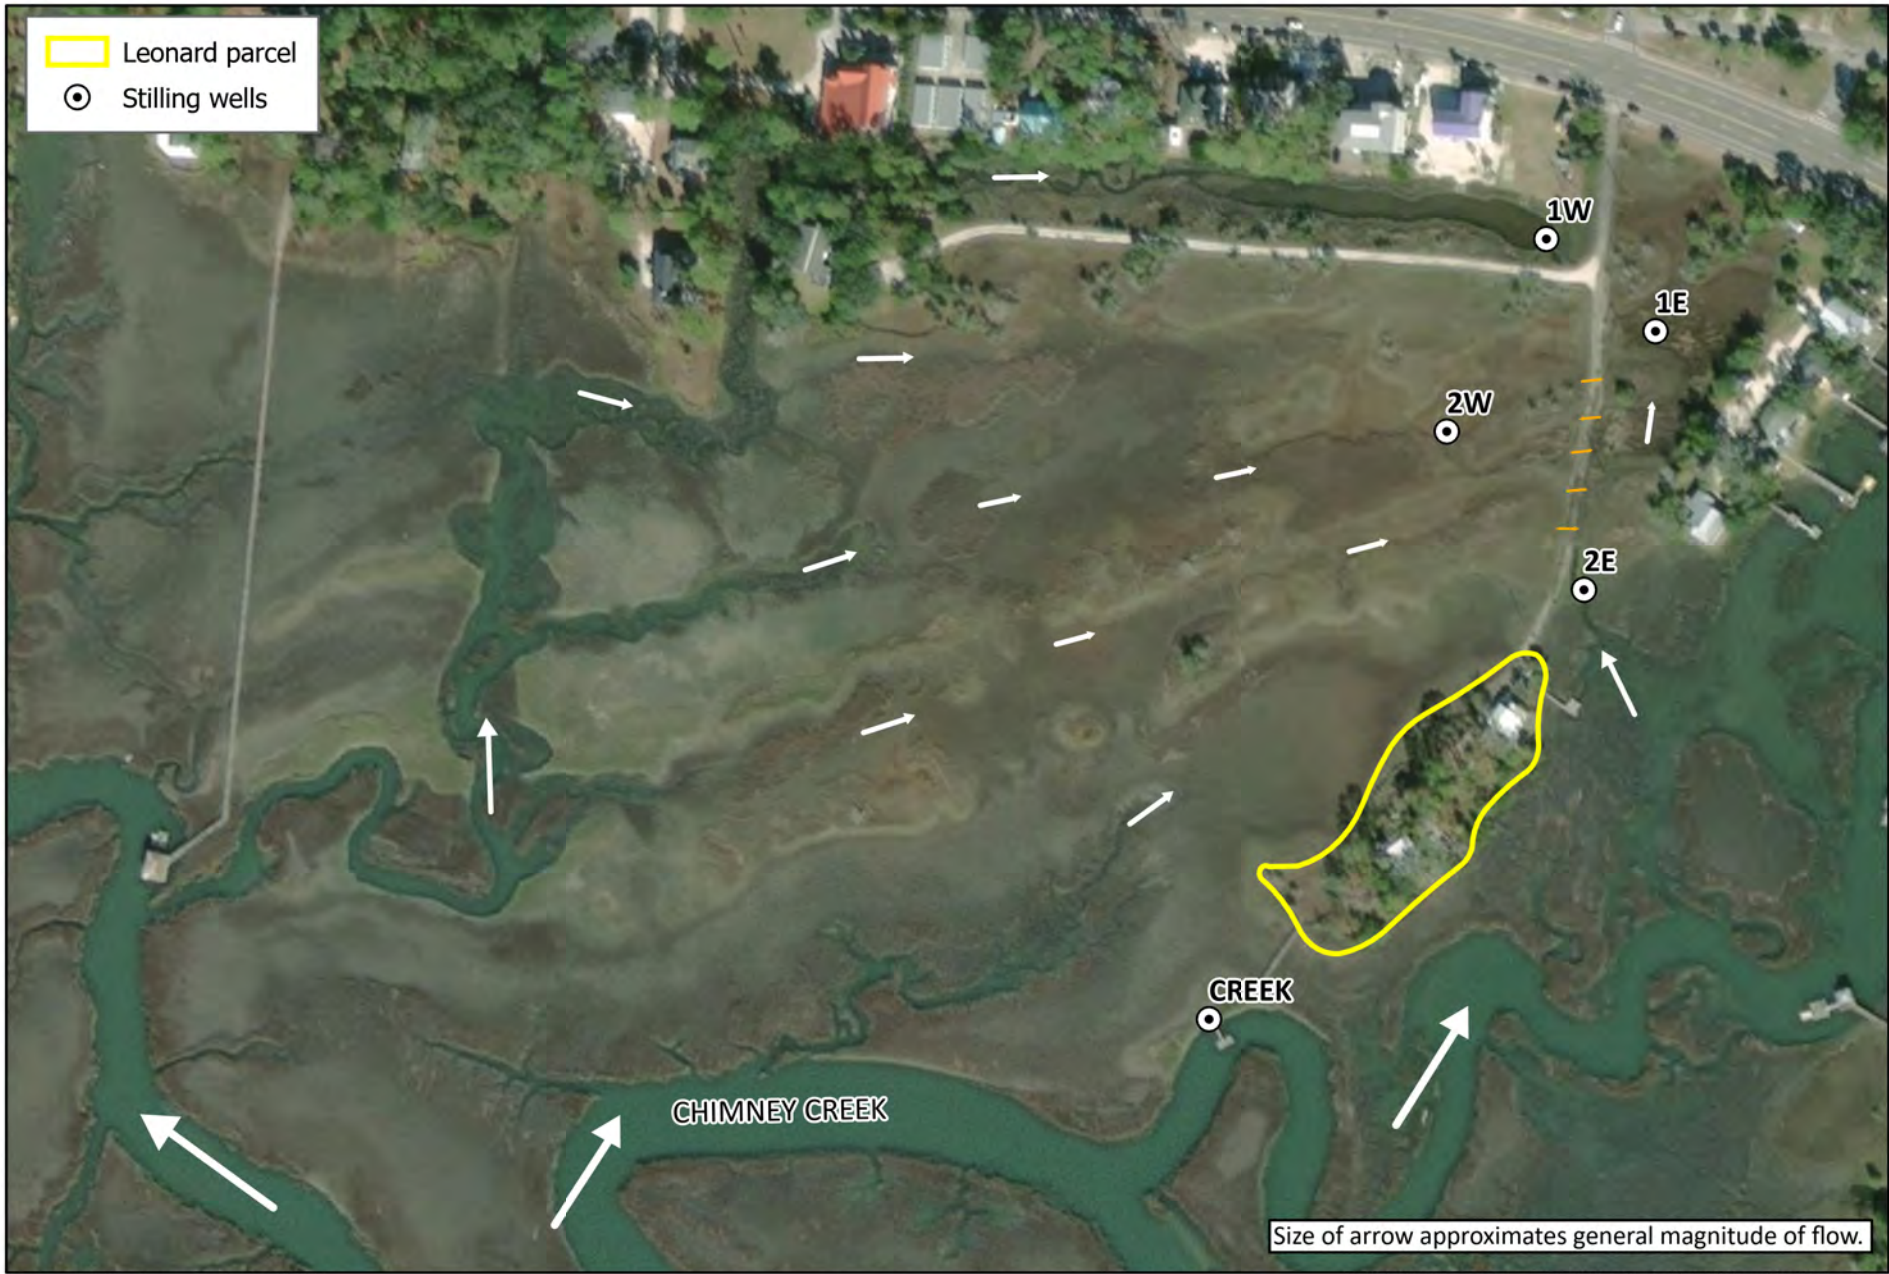
Figure 7. Primary water flowpaths into study area under current conditions. Orange arrows indicate areas where connectivity is limited to a small duration of time during high tide. Reference Figure 8 for more detail.

Road improvement and maintenance plans include the installation of three 18-inch culverts under the repaired roadway. Although the marshes have independent tidal sources, the culverts will provide an opportunity for hydrological and ecological connectivity during high tide (Figure 7).

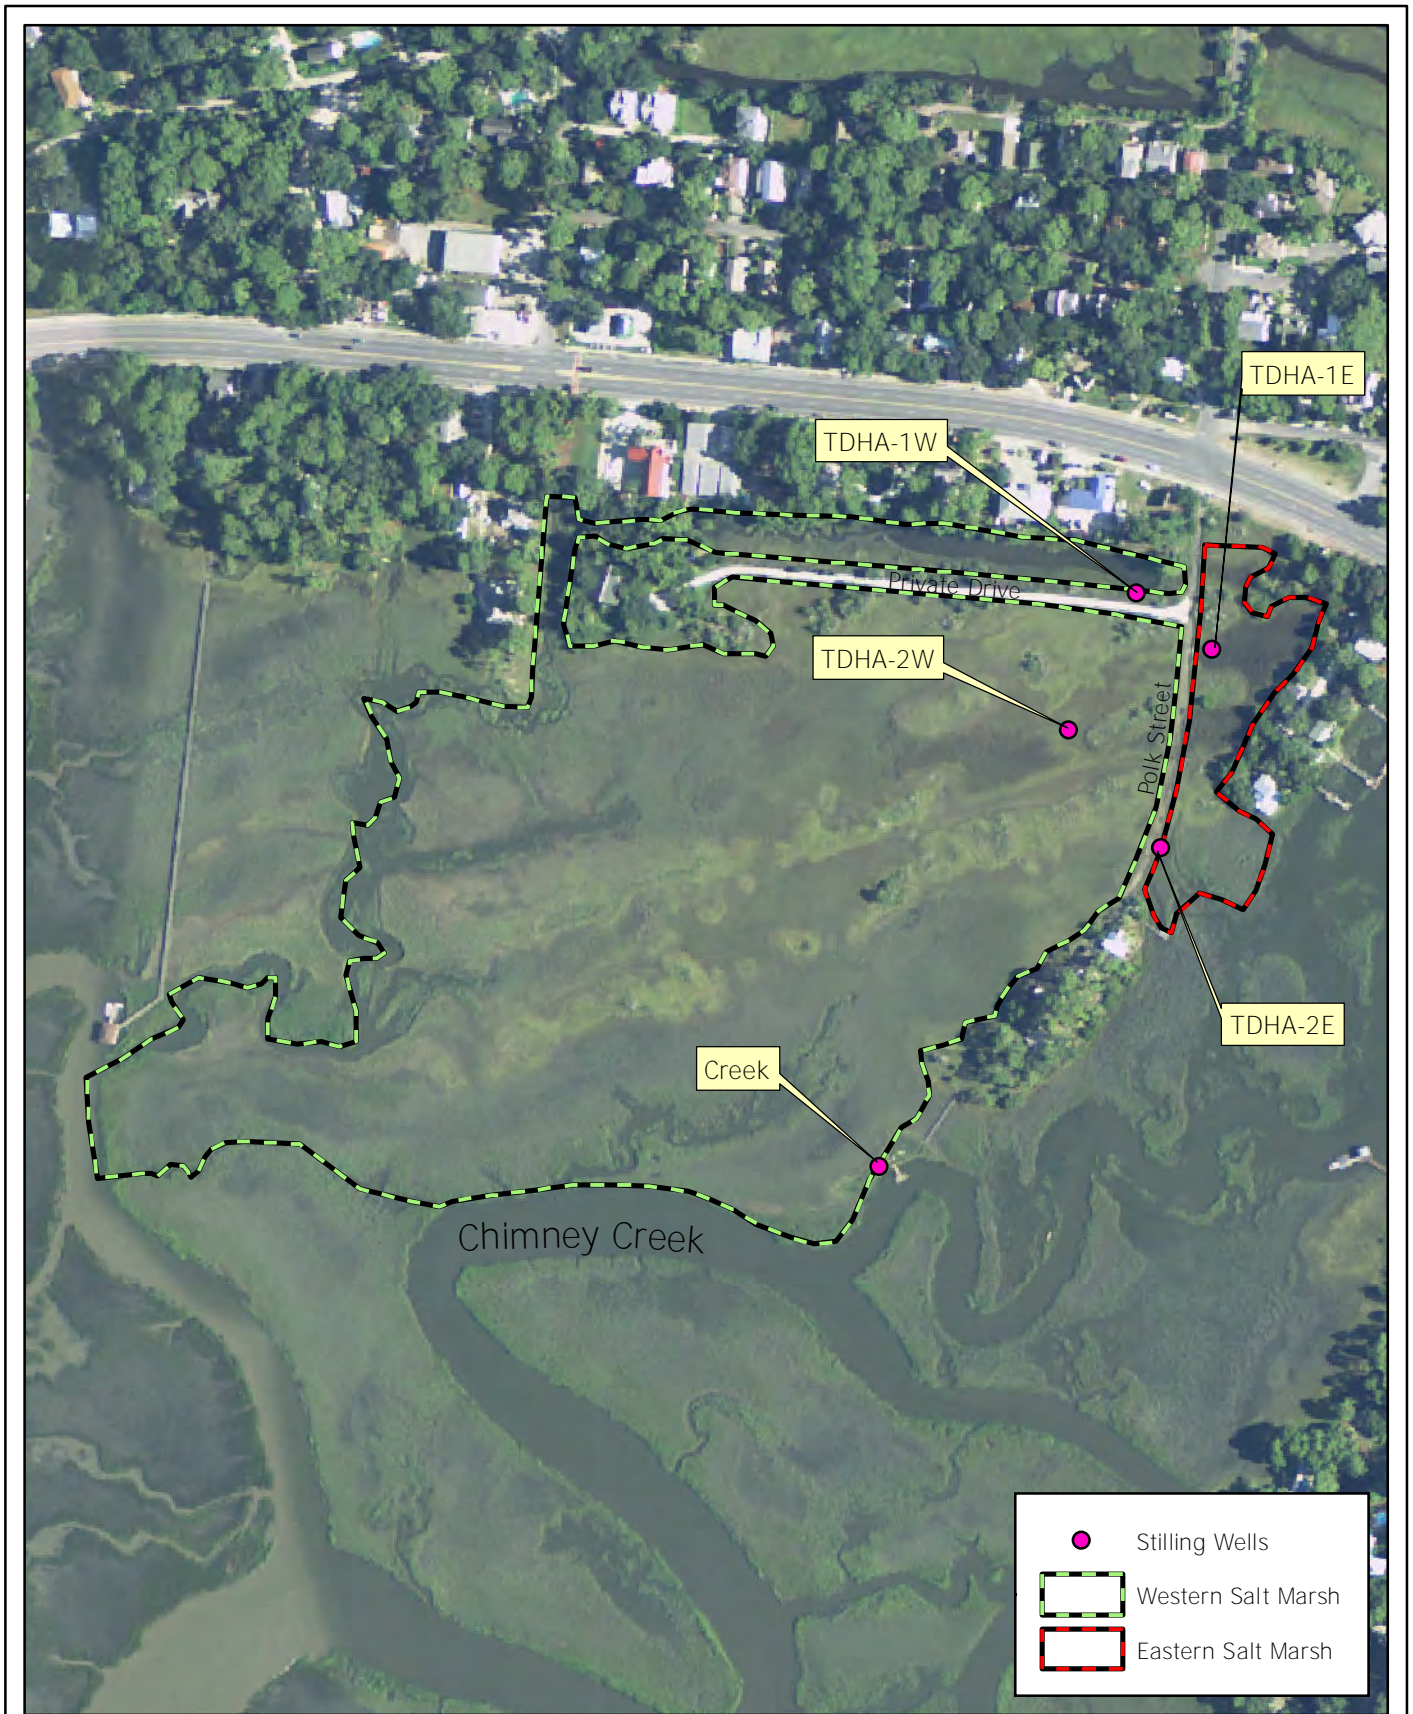
Figure 2. Stilling well locations and Eastern and Western Salt Marsh boundaries within the vicinity of the proposed driveway maintenance project.

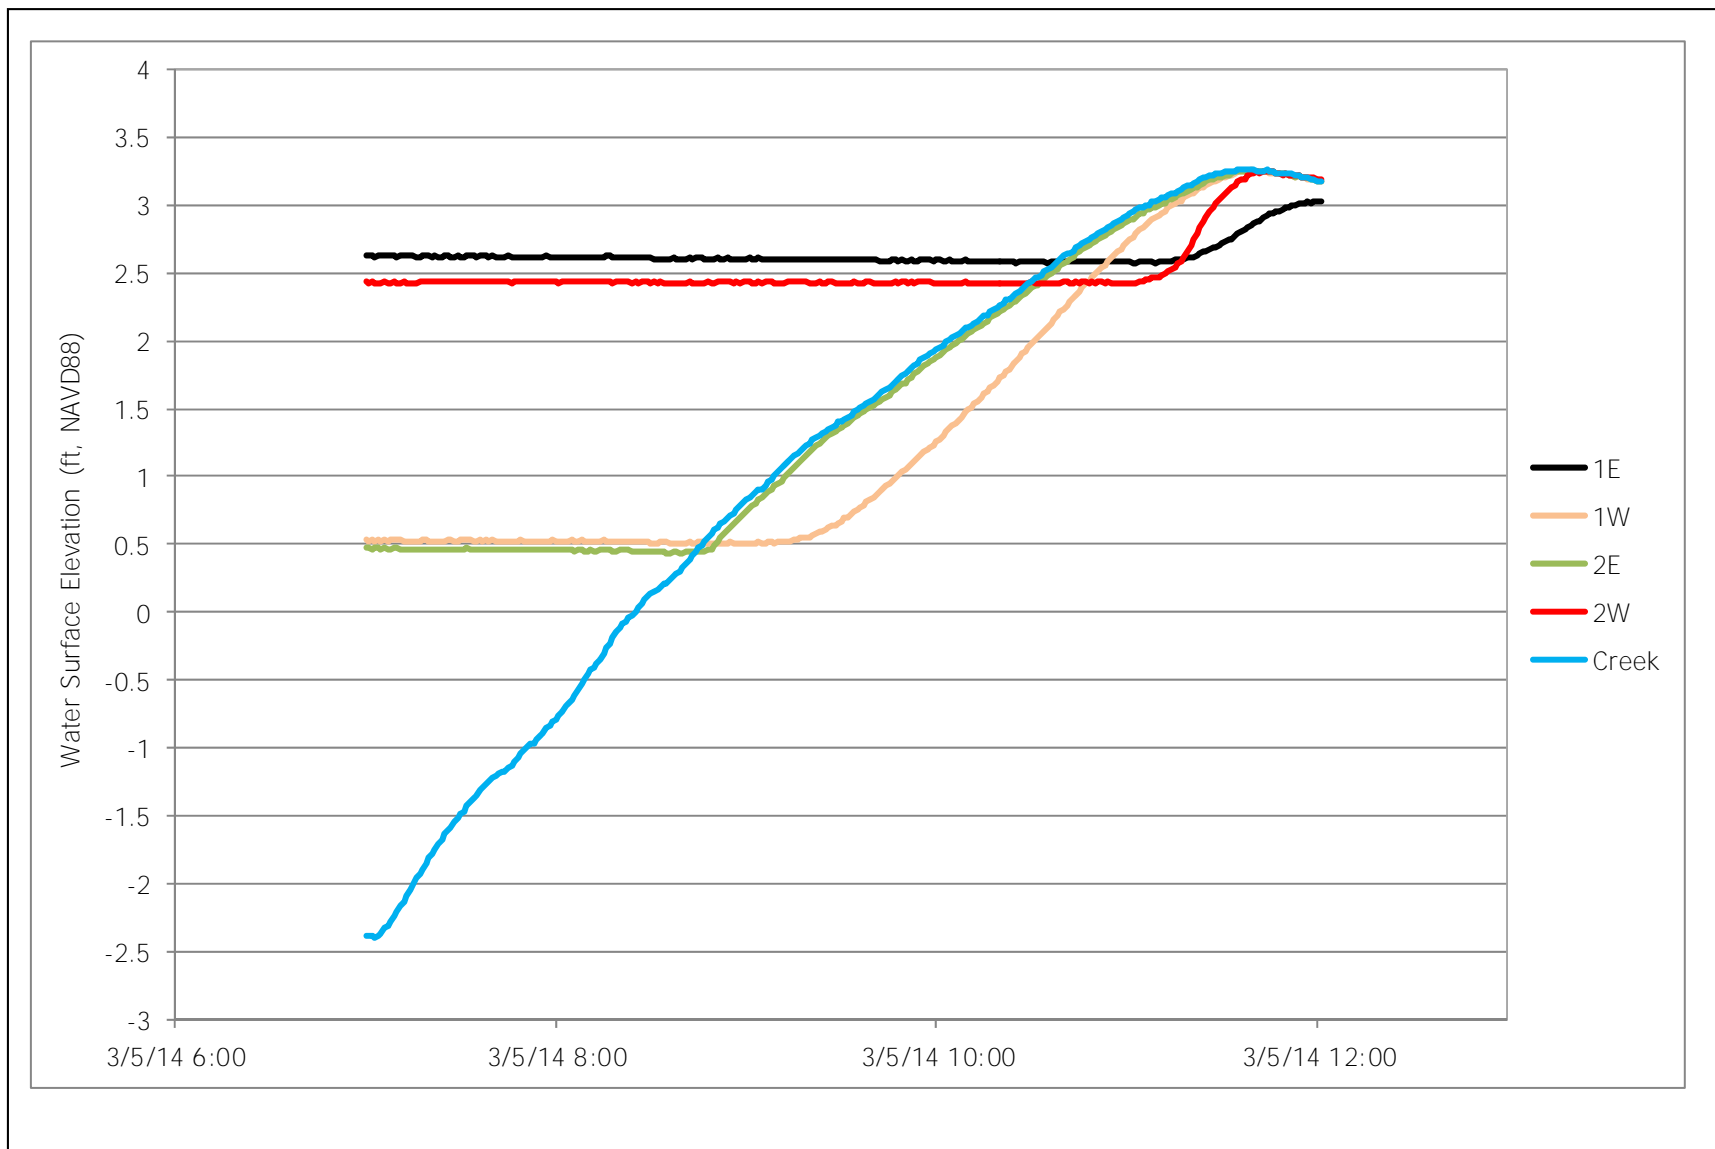
Figure 8. Water surface elevations recorded during the rising limb and peak of the lowest high tide event at stage recorders 1E, 1W, 2E, 2W, and Creek.

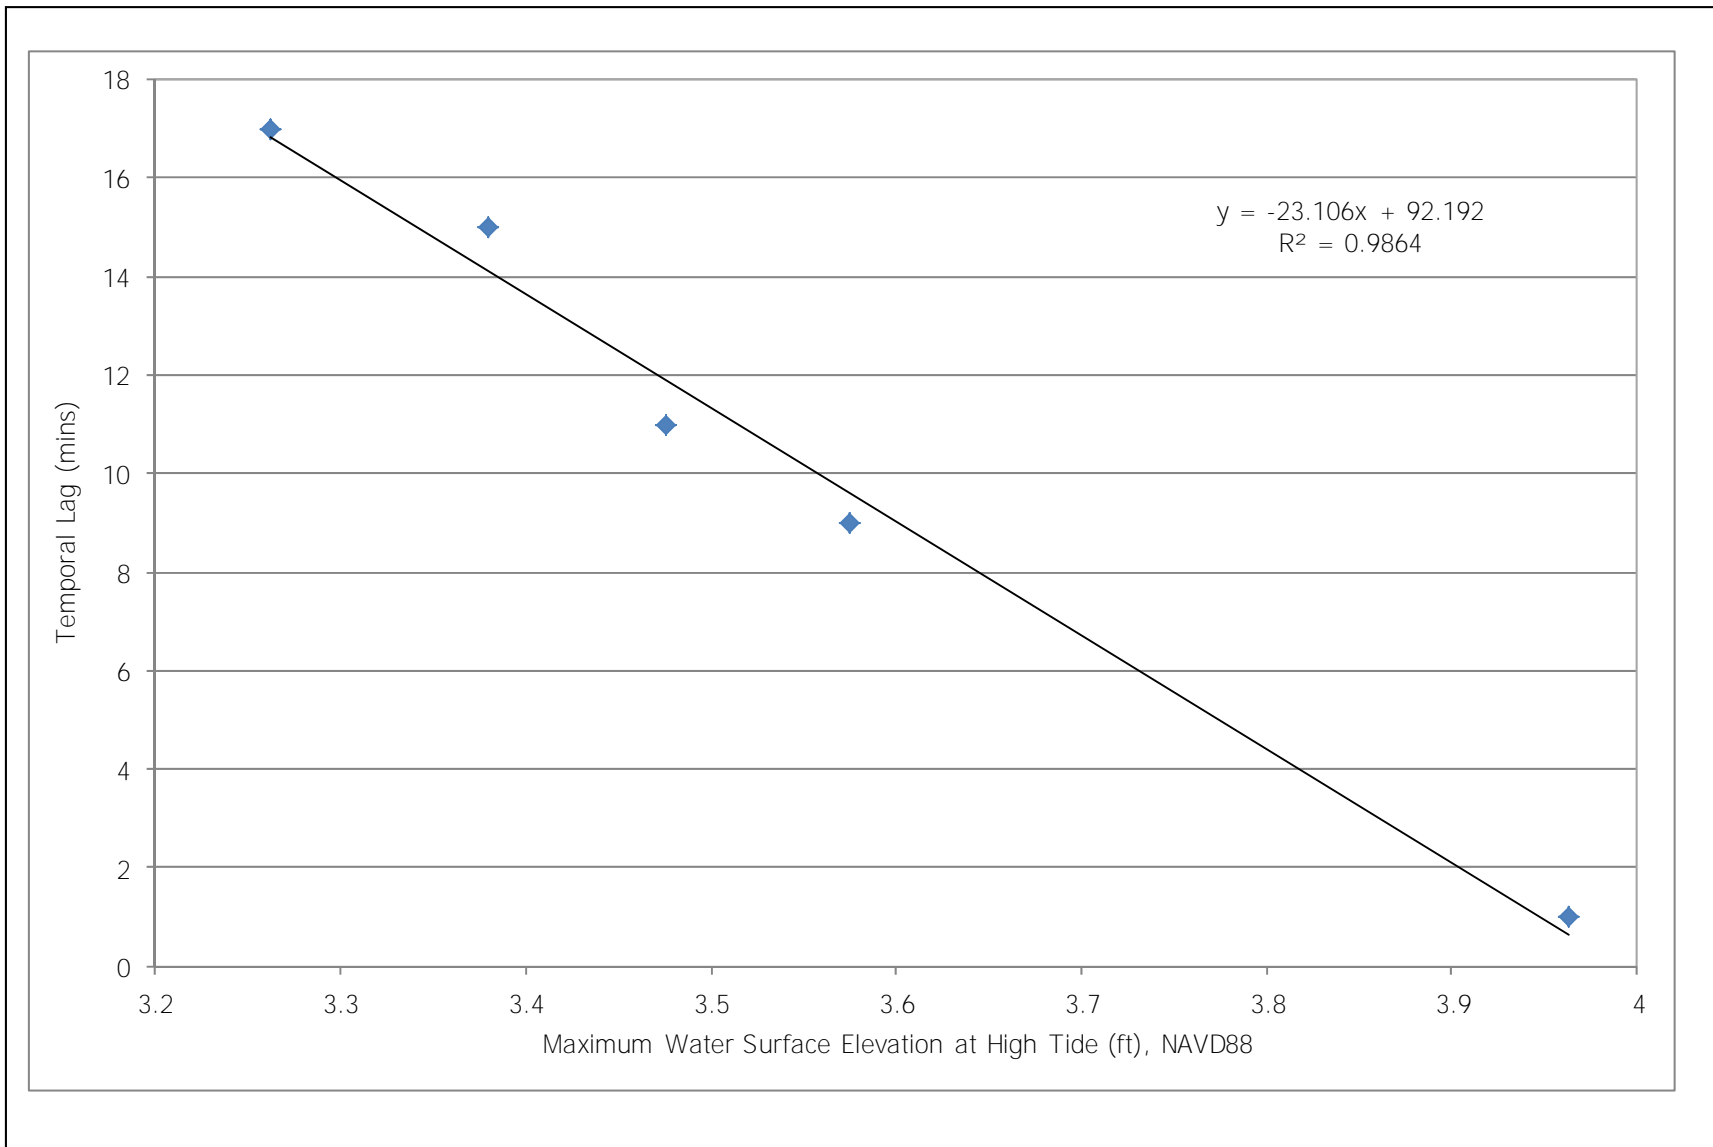
Figure 10. Temporal lag of high tide at 1E relative to Creek as a function of maximum tide elevation.

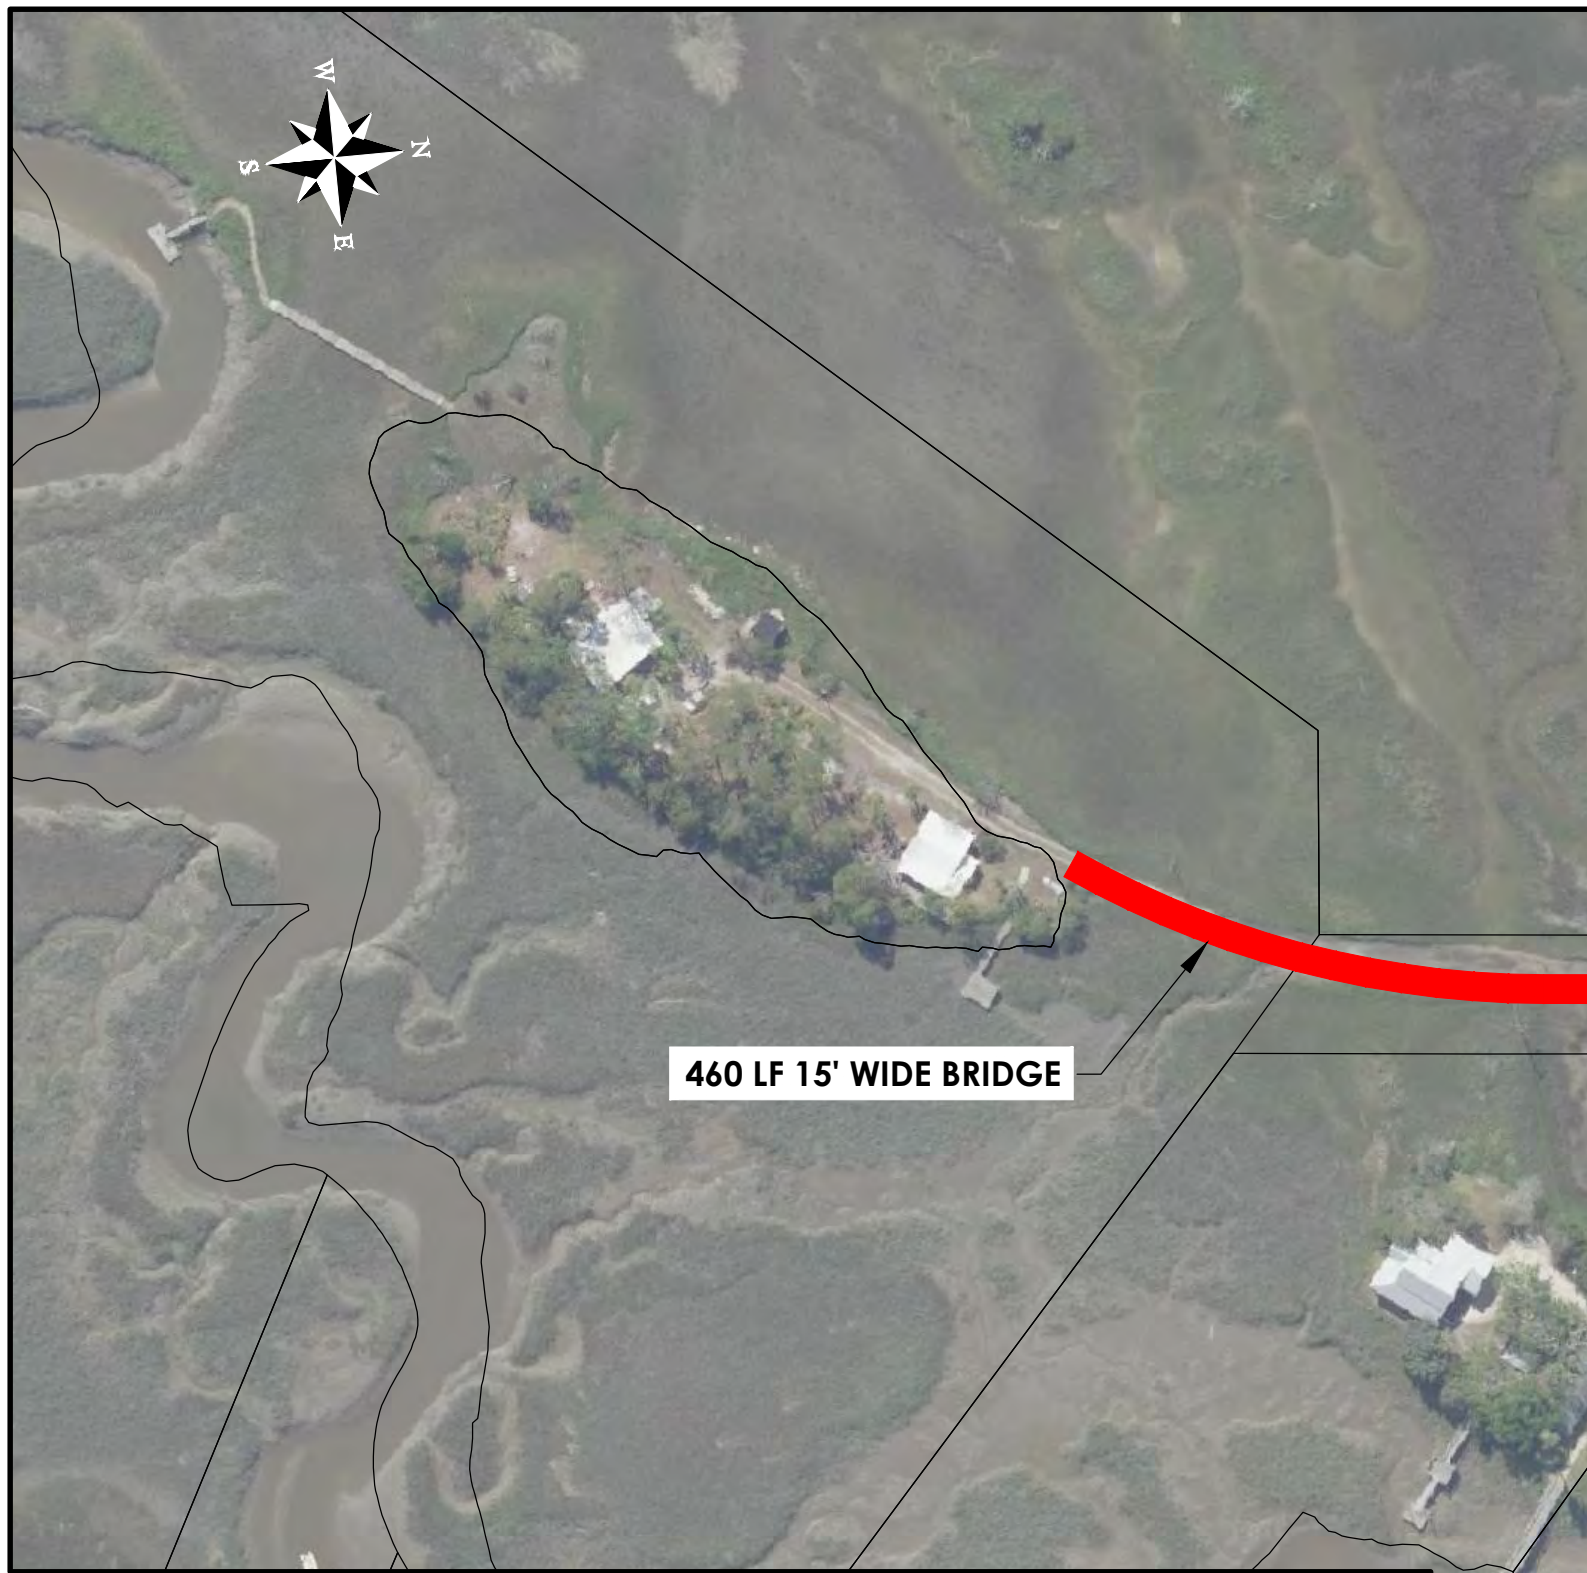
**CONCRETE BRIDGE OPTION 1**

UNIT COST = \$250 / SF

AREA OF BRIDGE = 460 LF X 15 FT = 6,900 SF

EST. BRIDGE COST = \$250/SF X 6,900 SF  
= \$1,725,000.00

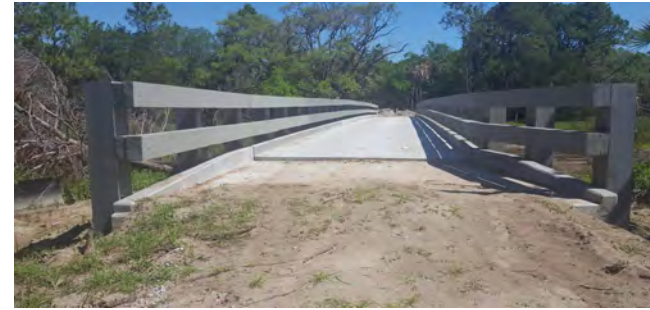
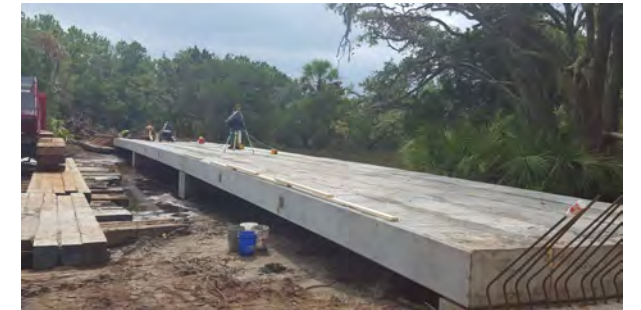
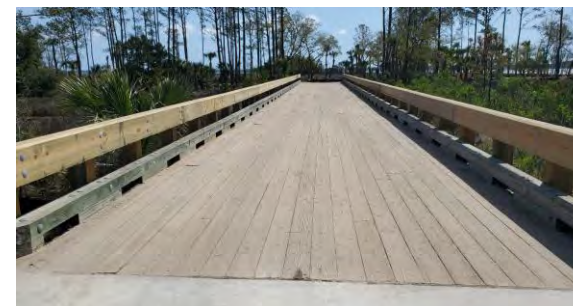
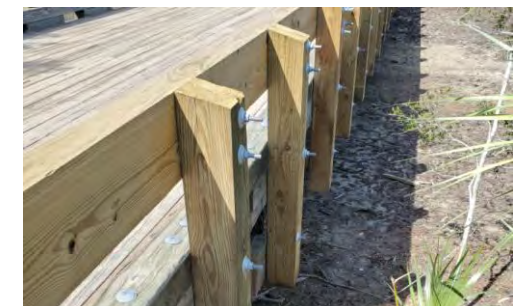
SHEET NAME:  
BRIDGE OPTION #1  
CLIENT:  
RESOURCE + LAND CONSULTANTS  
LOCATION: TYBEE ISLAND, GA  
DATE: 02/19/2021  
JOB NUMBER: J-29077  
DRAWN BY: KHT  
REVIEWED BY: JVG  
SHEET: EX2  
SCALE: 1" = 100'

**TIMBER BRIDGE OPTION 1**

UNIT COST = \$215 / SF

AREA OF BRIDGE = 460 LF X 15 FT = 6,900 SF

EST. BRIDGE COST = \$215/SF X 6,900 SF  
= \$1,483,500.00

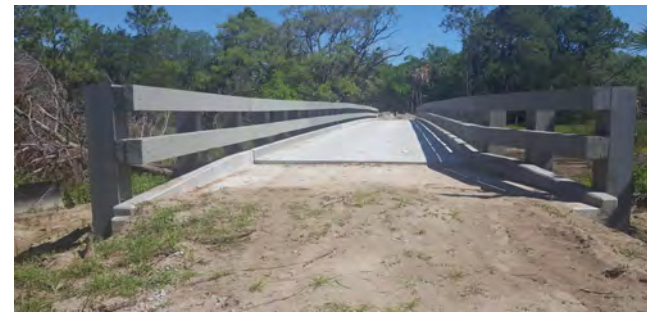
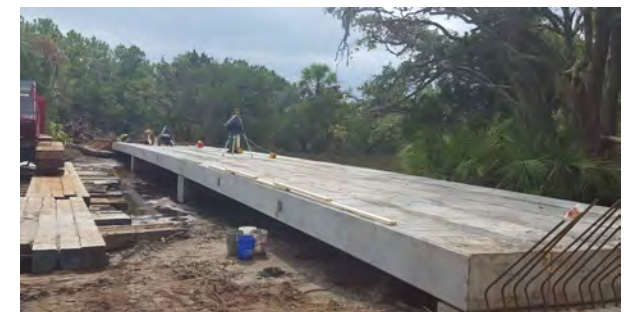
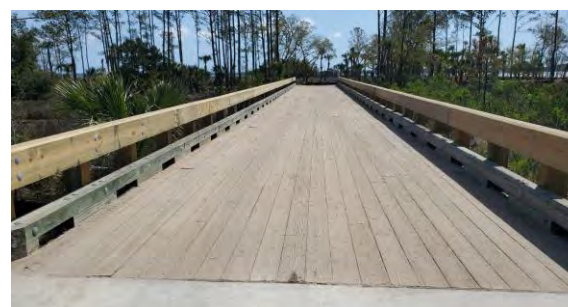
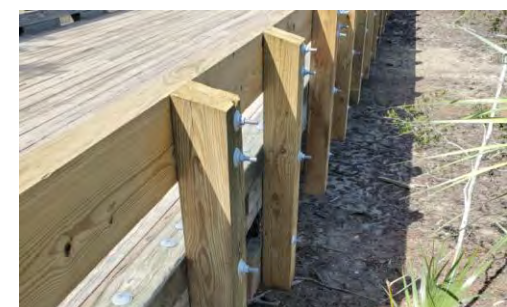
SHEET NAME:  
BRIDGE OPTION #2  
CLIENT:  
RESOURCE + LAND CONSULTANTS  
LOCATION: TYBEE ISLAND, GA  
DATE: 02/19/2021      DRAWN BY: KHT      SHEET: EX3  
JOB NUMBER: J-29077      REVIEWED BY: JVG      SCALE: 1" = 100'

UNIT COST = \$325 / SF      AREA OF BRIDGE = (111' + 106' + 102') X 15 FT = 4,785 SF

EST. BRIDGE COST = \$325/SF X 4,785 SF  
= \$1,555,125.00

106 LF 15' WIDE BRIDGE

111 LF 15' WIDE BRIDGE

UNIT COST = \$275 / SF      AREA OF BRIDGE = (111' + 106' + 102') X 15 FT = 4,785 SF

EST. BRIDGE COST = \$275/SF X 4,785 SF  
= \$1,315,875.00
