Figure 4. Project area for the Cabretta and Big Hole Creek Restoration Project. Proposed test plots demarcated with red dots. NOAA Navigational Chart # 11509_1. Proposed sites are approximate. Exact locations will be determined through community meetings and modeling exercises as described in Appendix I text.

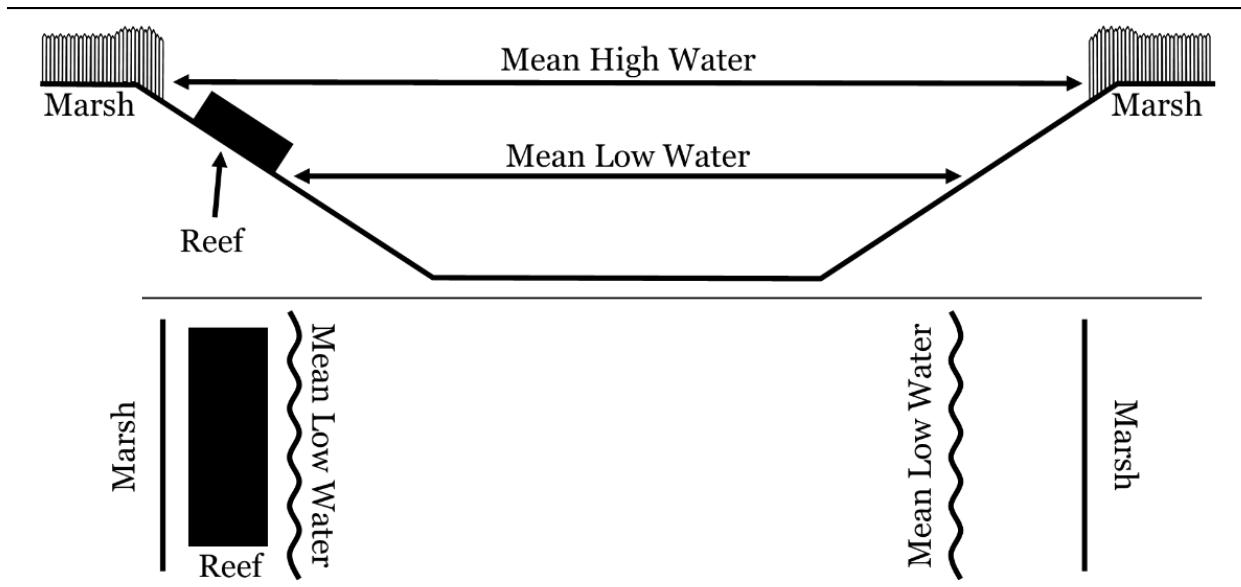
Figure 1. Section plan for oyster restoration with cultch deployed at or above MLW below the marsh line.

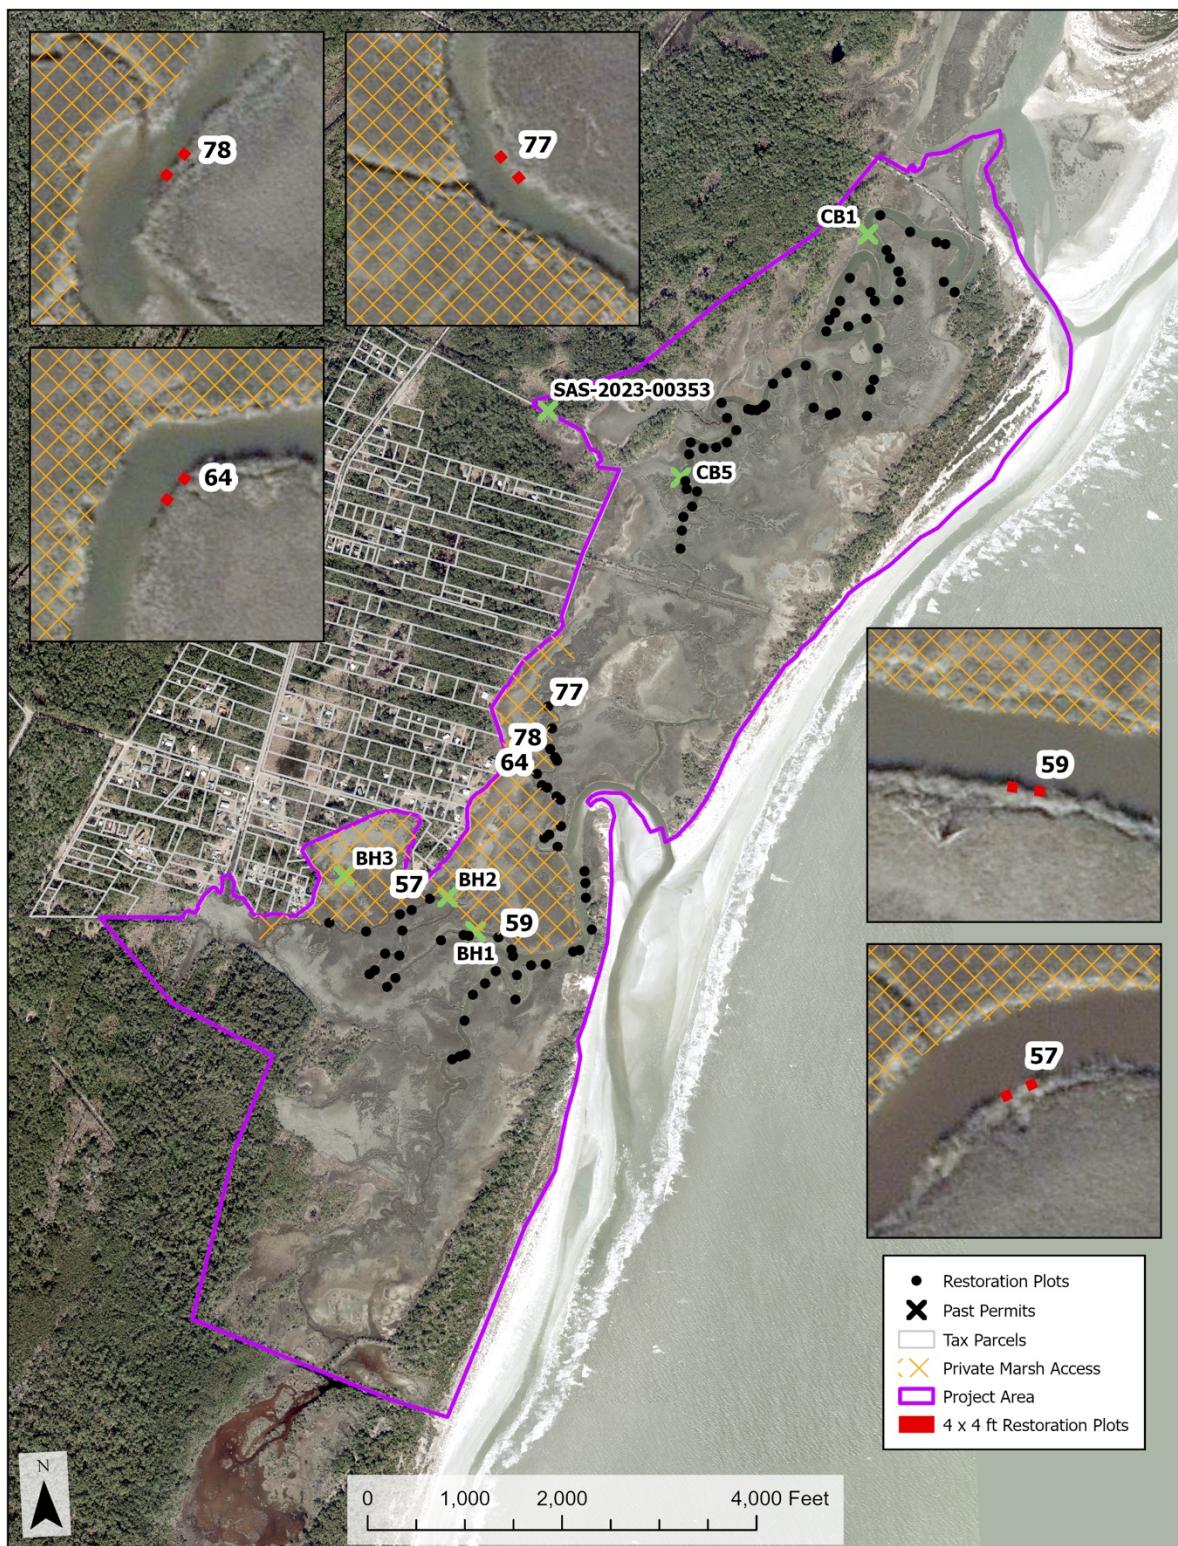
Figure 2. Aerial photography of the project site taken near low tide in 2018. Proposed restoration plots marked with black dots. Proposed sites are approximate. Exact locations will be determined through community meetings and modeling exercises as described in appendix text.
