**Re: Letter of Permission (LOP) for Sapelo Island Nature Trail Footbridge Repairs, Sapelo Island National Estuarine Research Reserve, Sapelo Island, McIntosh County, Georgia.
GPS: (31.39479°N/-81.26983°W)**

Boardwalk emergency repair on Sapelo Island

IMAGES OF NATURE TRAIL, DEAN CREEK AND REPAIRS NEEDED.

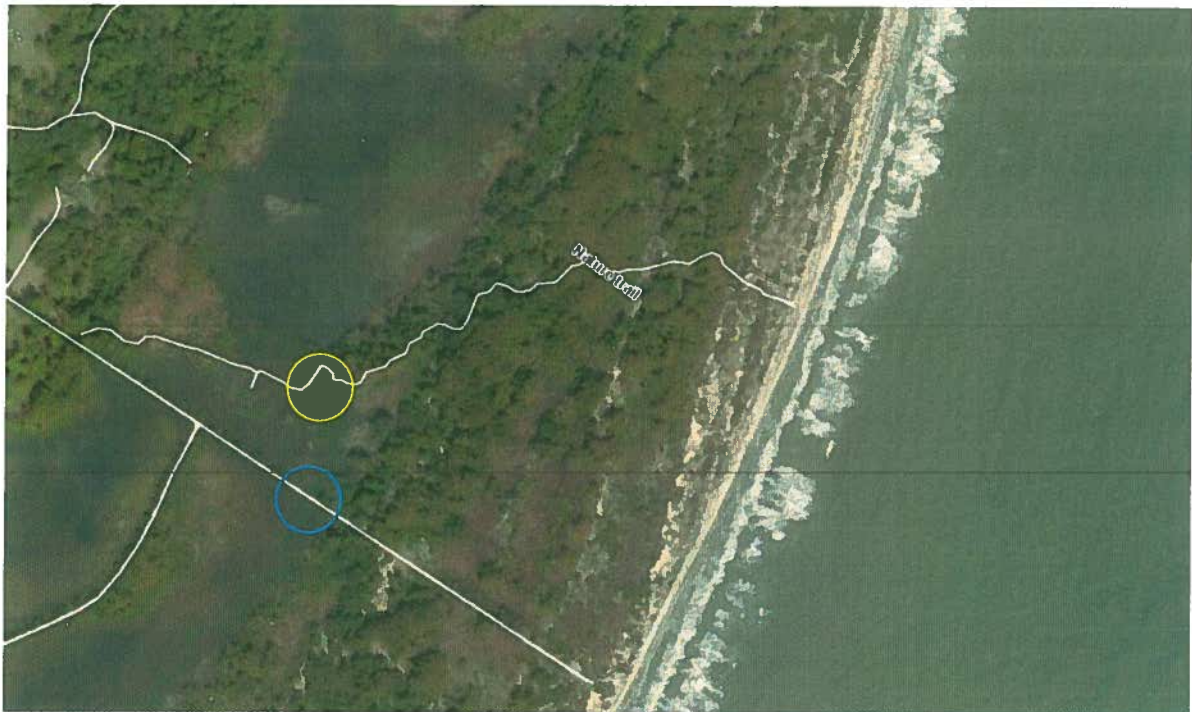
○ Gangway

○ Bridge over Dean Creek

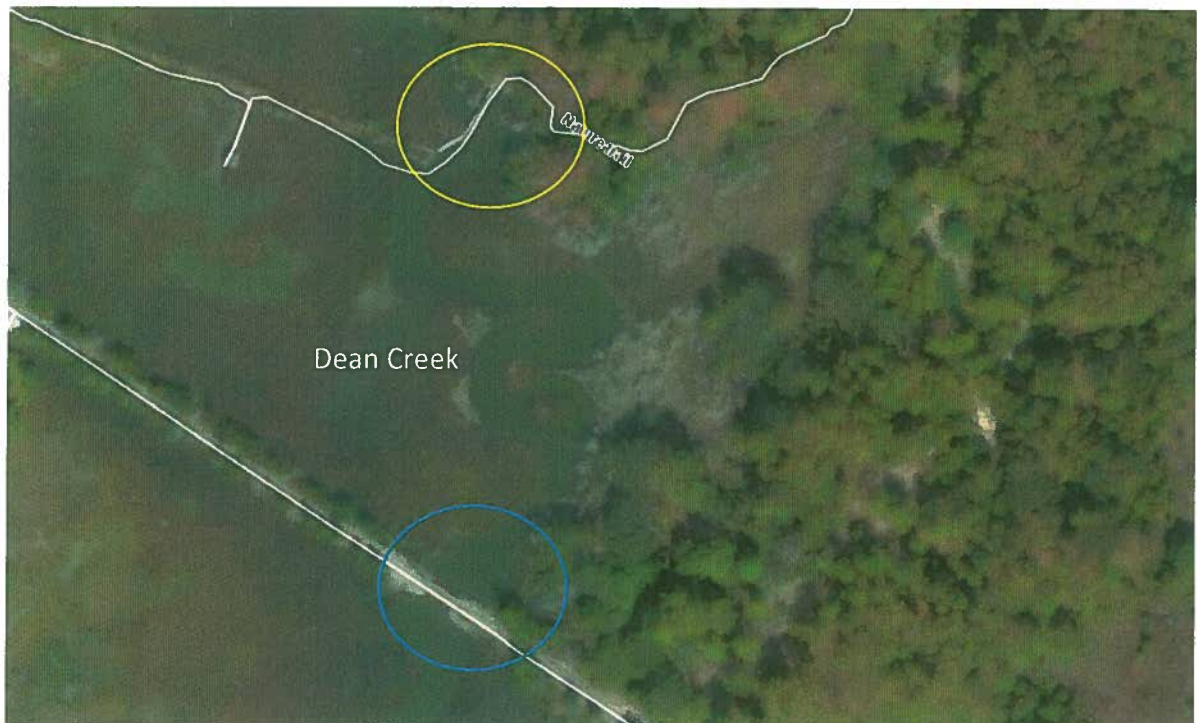
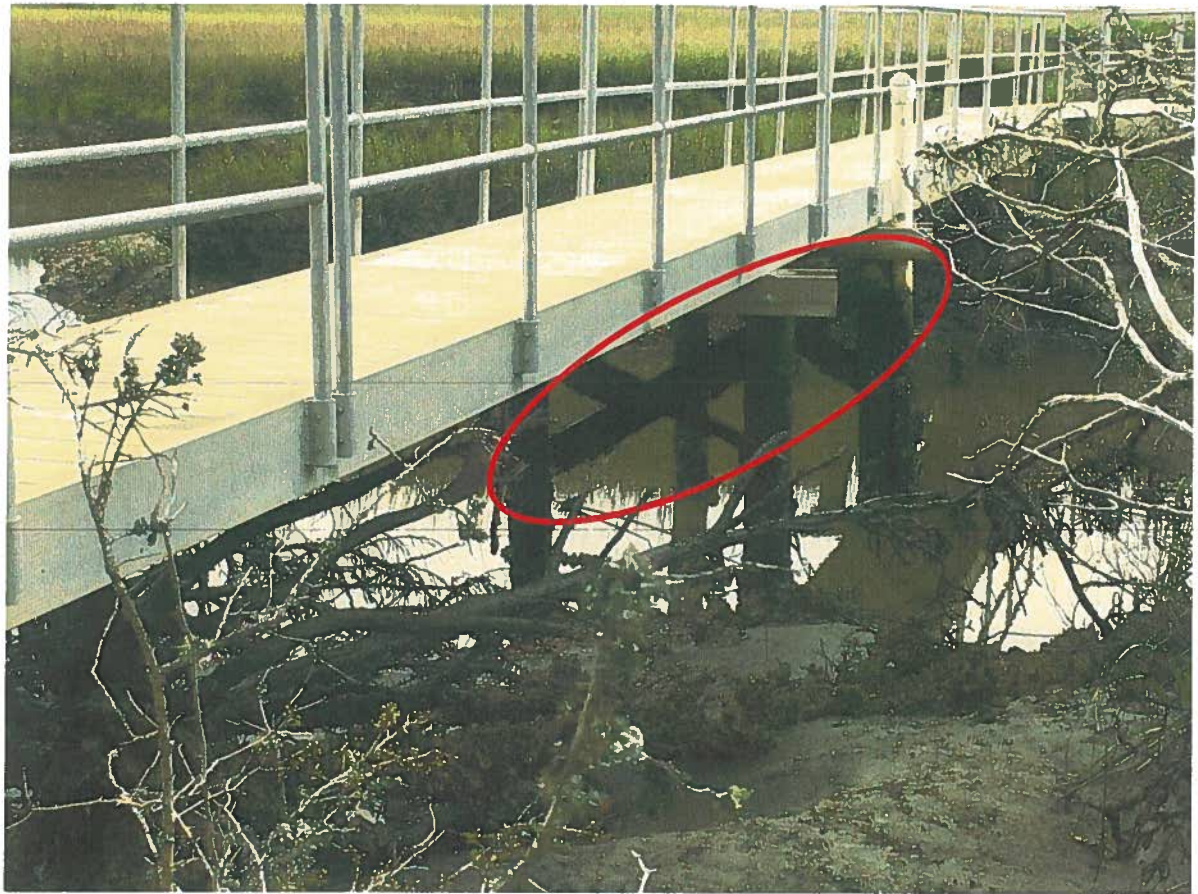
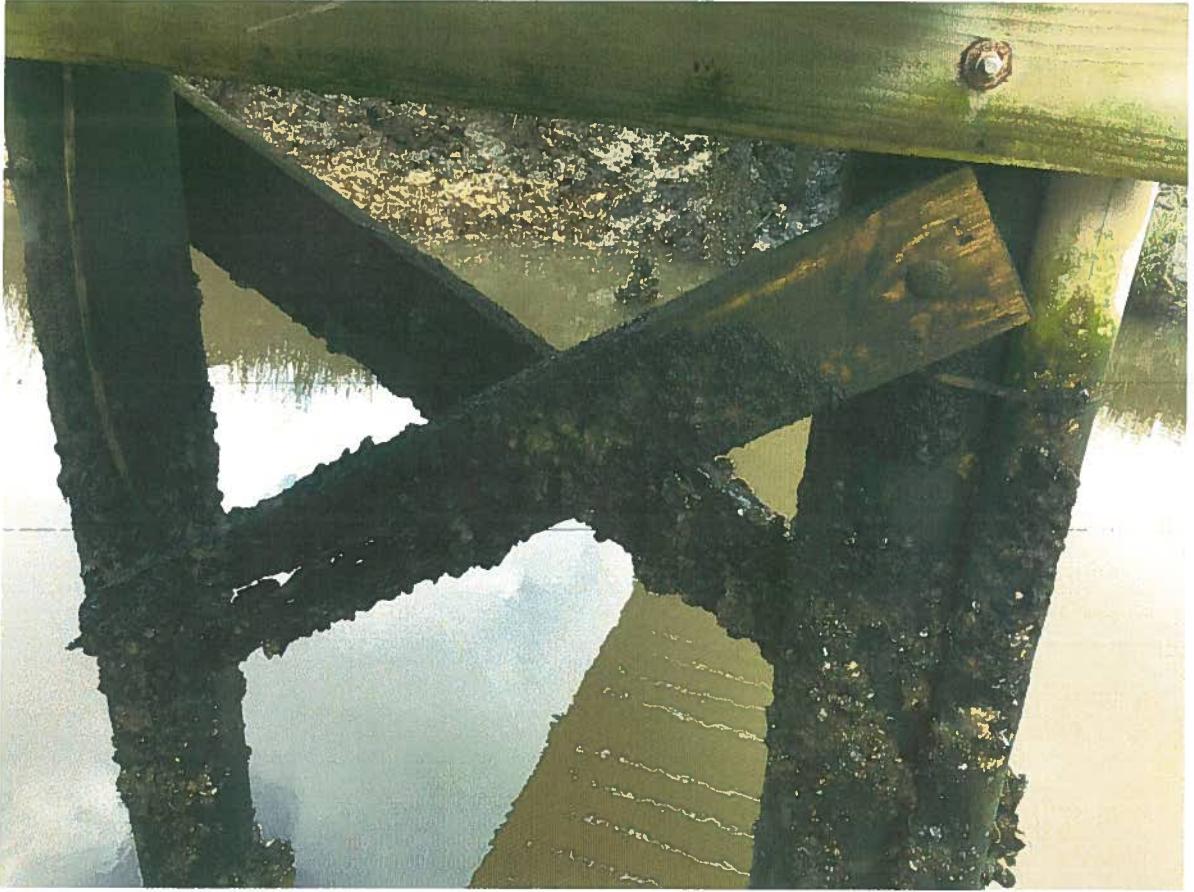
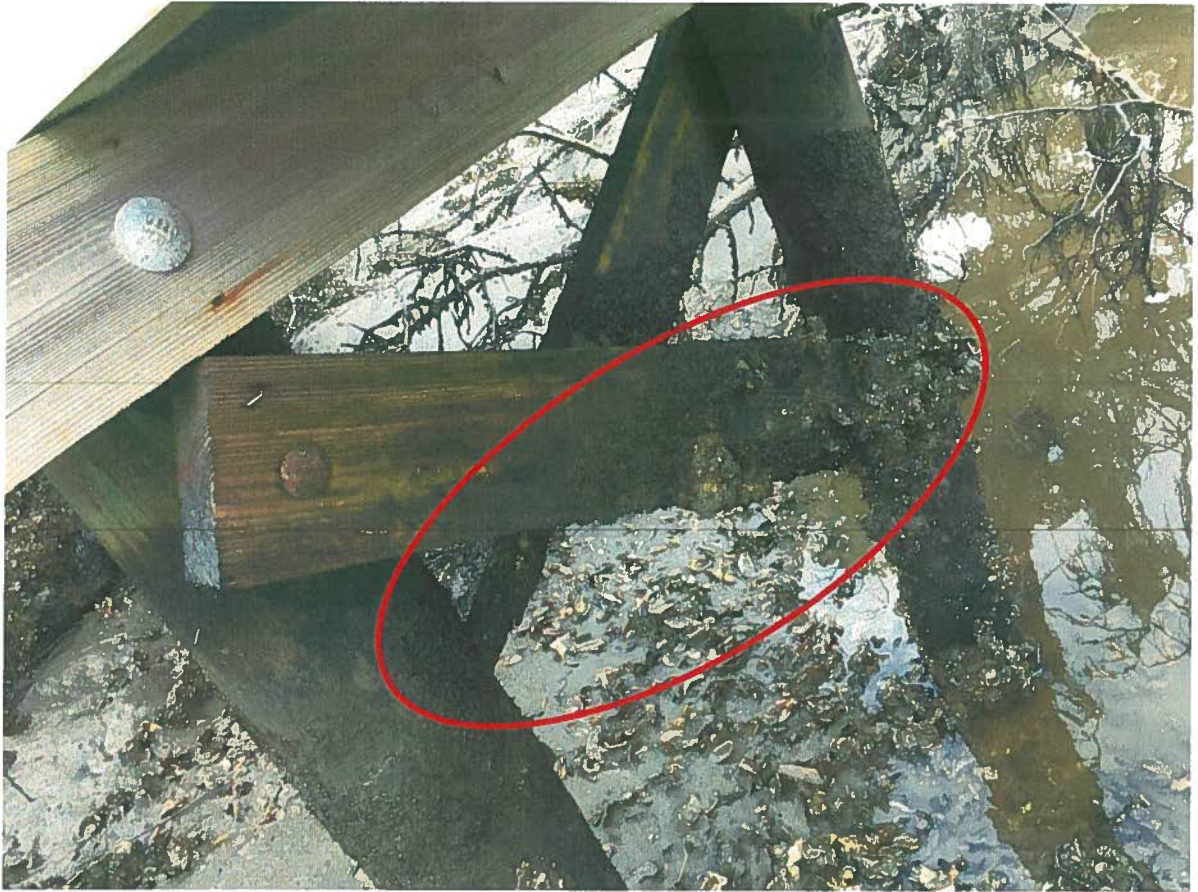
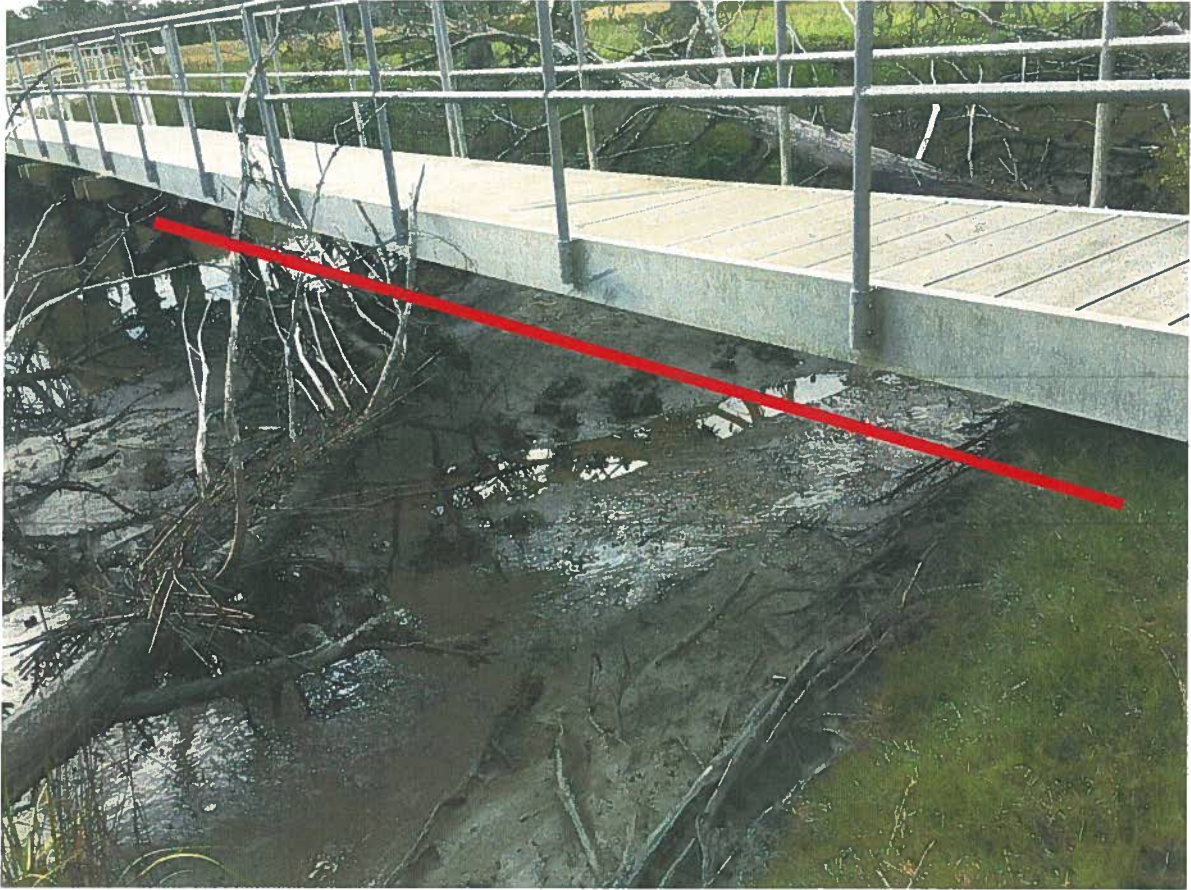
The north bend of the creek has eroded significantly, and the creek is considerably wider than when the initial support beams were placed for the gangway. This has compromised the stability of the gangway on the distal side of the trail by creating 84 feet of unsupported span. In addition, four sets of the cross-brace members between the pilings are severely rotten and need to be replaced. One of the current support beams houses one of our SWMP sonde units and this is a frequently used trail by many visitors and their safety is our immediate concern.

Support needed.

According to the request, four cross-brace members will be replaced between pilings where the existing members are deteriorated. Four additional 10-inch diameter wood piles will be installed to support the footbridge where the creek has eroded leaving 84 ft. of unsupported span. Equipment needed to complete the work includes the use of a 10' aluminum boat to guide the piles, a 3-inch pump, a pulley, and hand tools. There will be no changes to the current footprint of this existing footbridge. The project will begin no sooner than 15 days from the date of this letter and must be completed within six (6) months from the date of this letter.

Four piles will be installed under the exiting gangway and we will be replacing four sets of the cross-brace members, correct.
