Map of existing structures at Little River inshore artificial reef with side scan sonar imagery taken at high tide on June 14th, 2018.

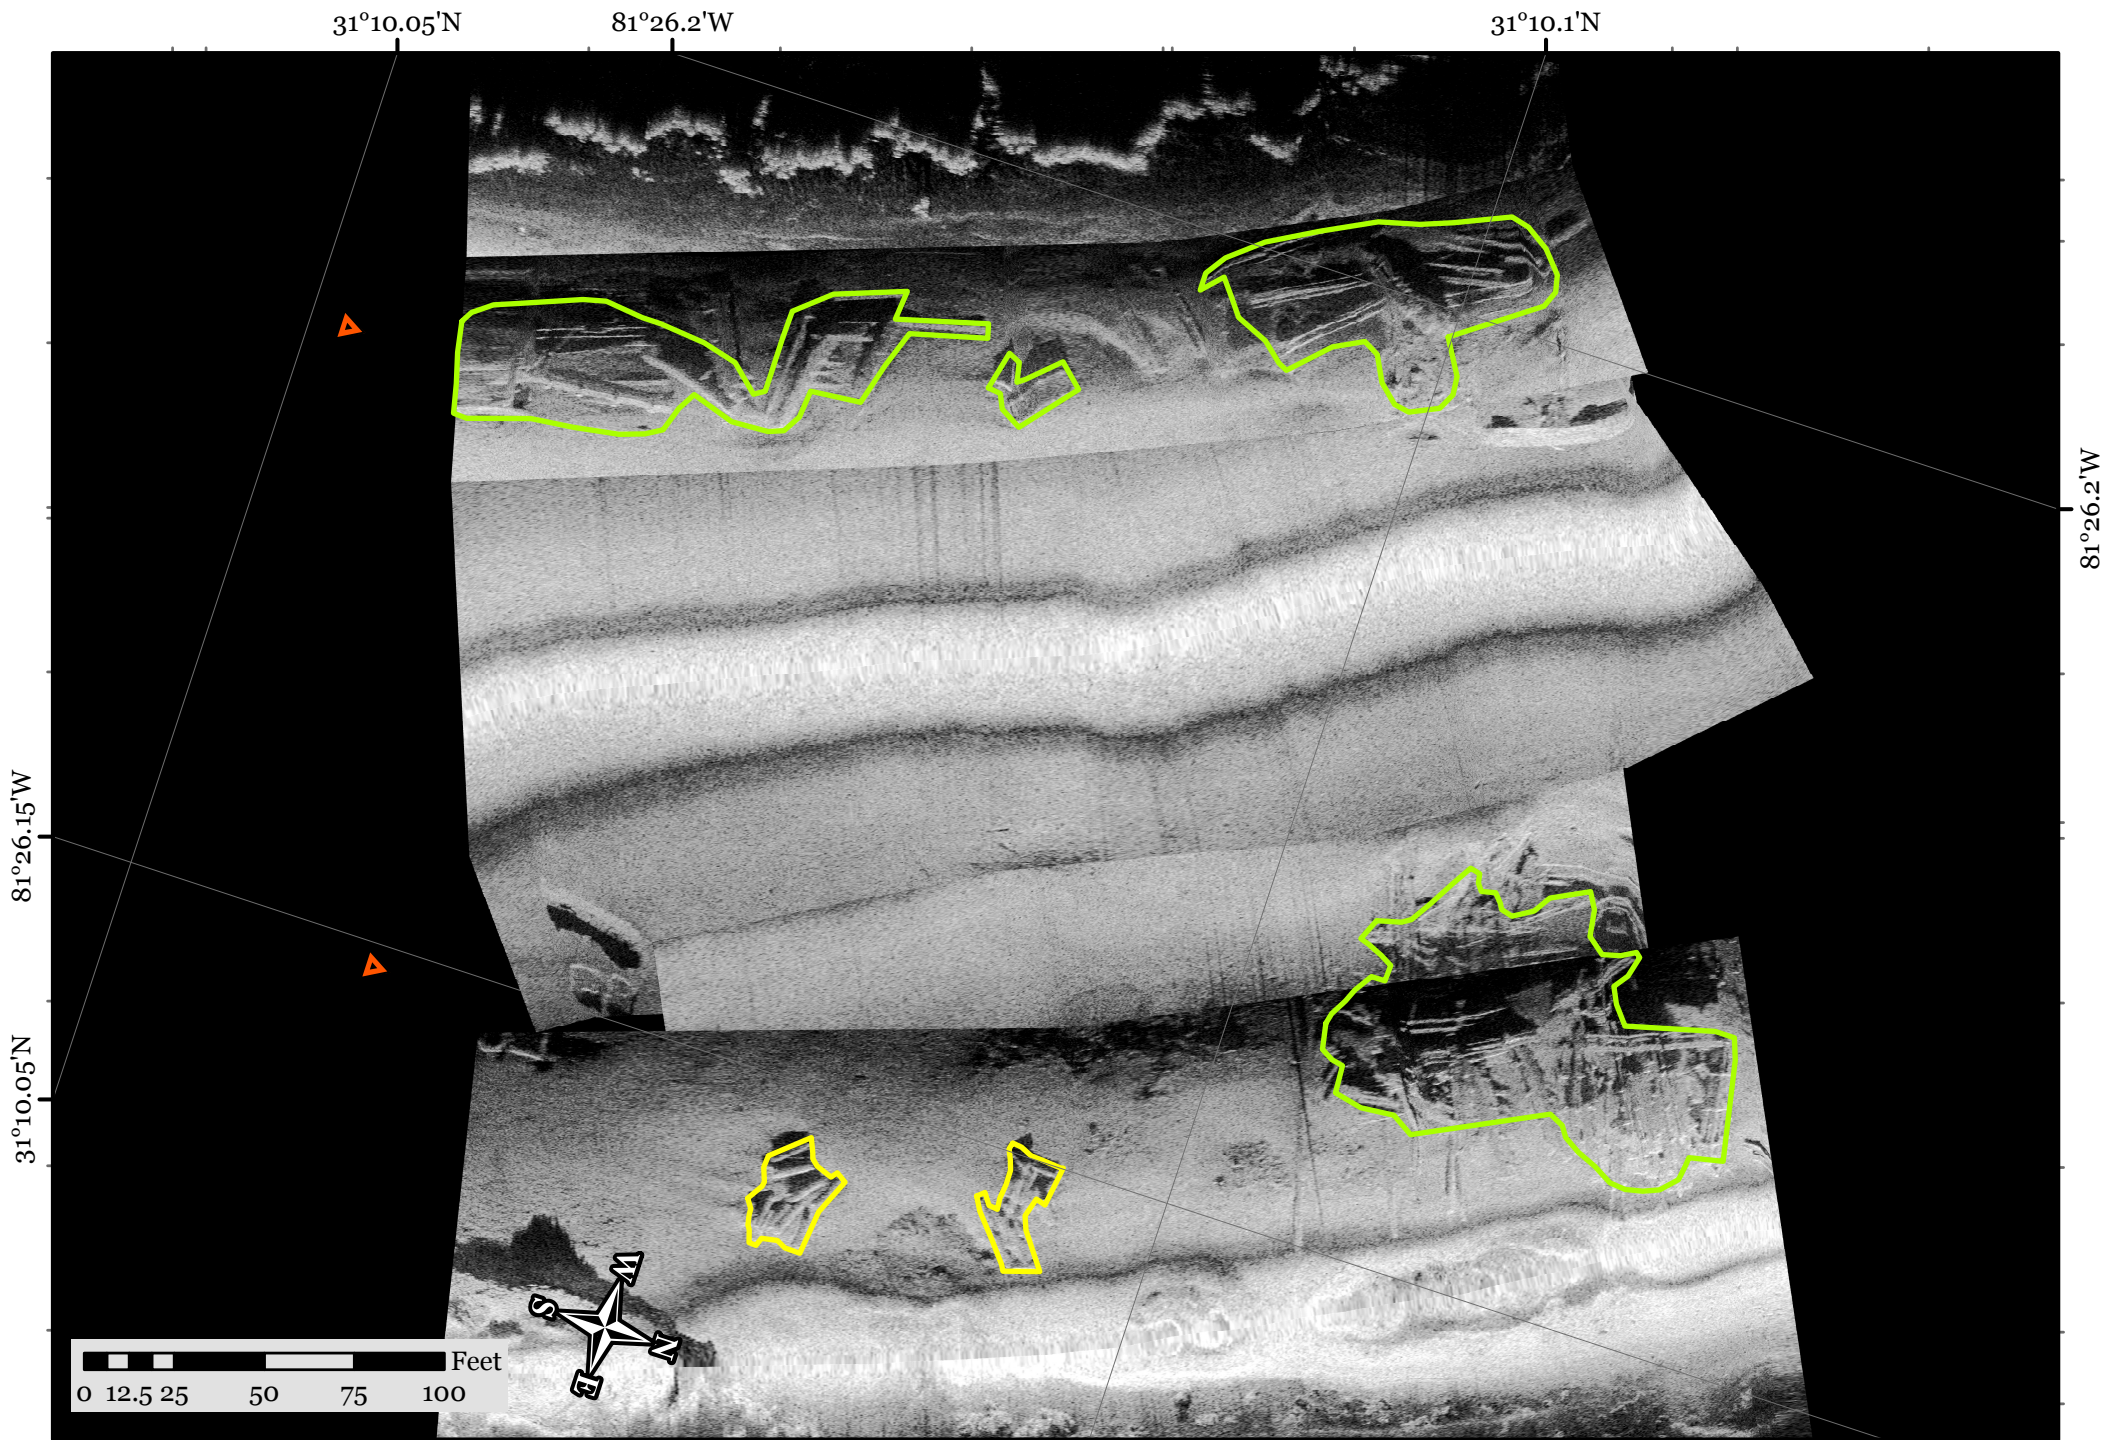
Pilings
-

Concrete Pole
-

Concrete Rubble
